Dowel Bar Retrofit – Do's and Don'ts

WA-RD 576.2

March 2009

16. ABSTRACT This report documents construction and inspection guidelines for the successful construction of a dowel bar retrofit project.			
17. KEY WORDS Dowel bar retrofit, concrete rehabilitation, construction techniques		18. DISTRIBUTION STATEMENT No restrictions. This document is available to the public through the National Technical Information Service, Springfield, VA 22616

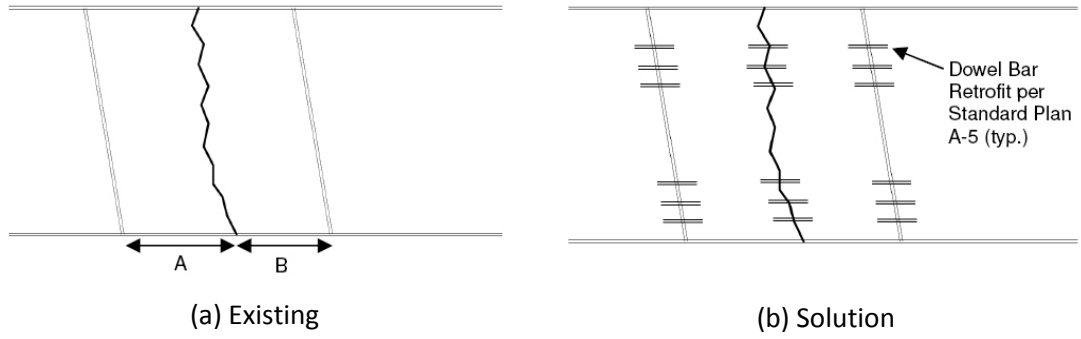
Figure 1 Mid panel transverse crack (A and B greater than three feet).

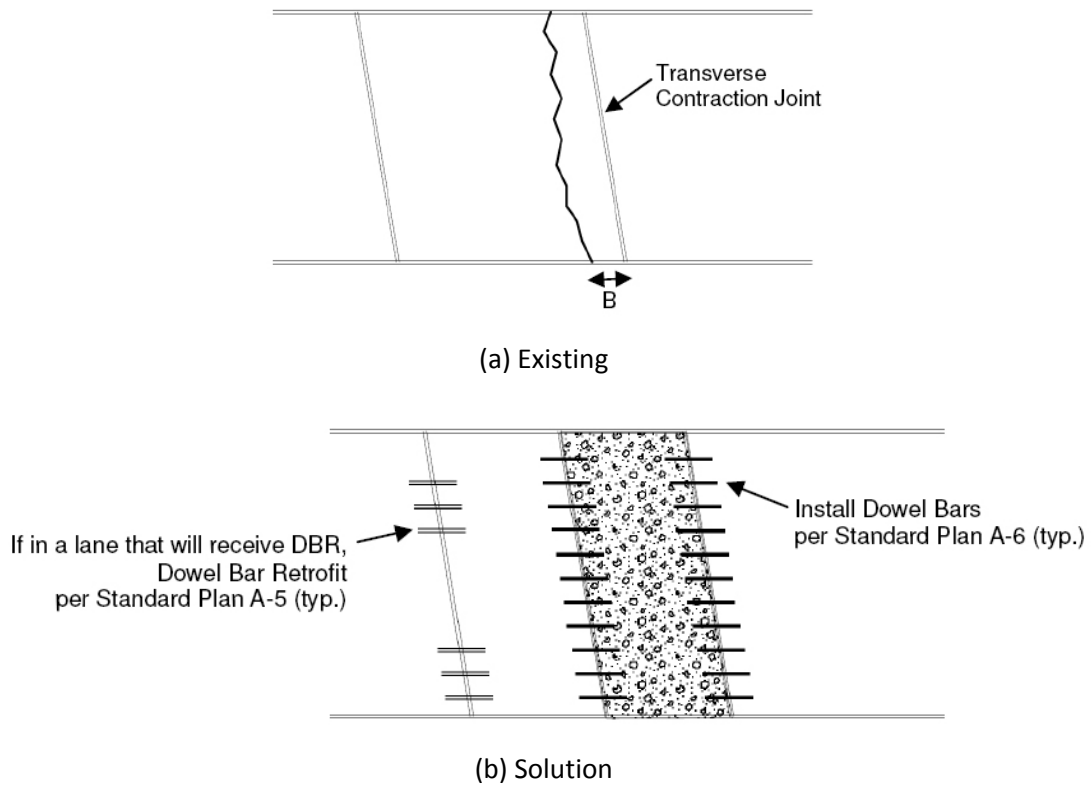
Figure 2 Existing transverse crack (B < three feet).

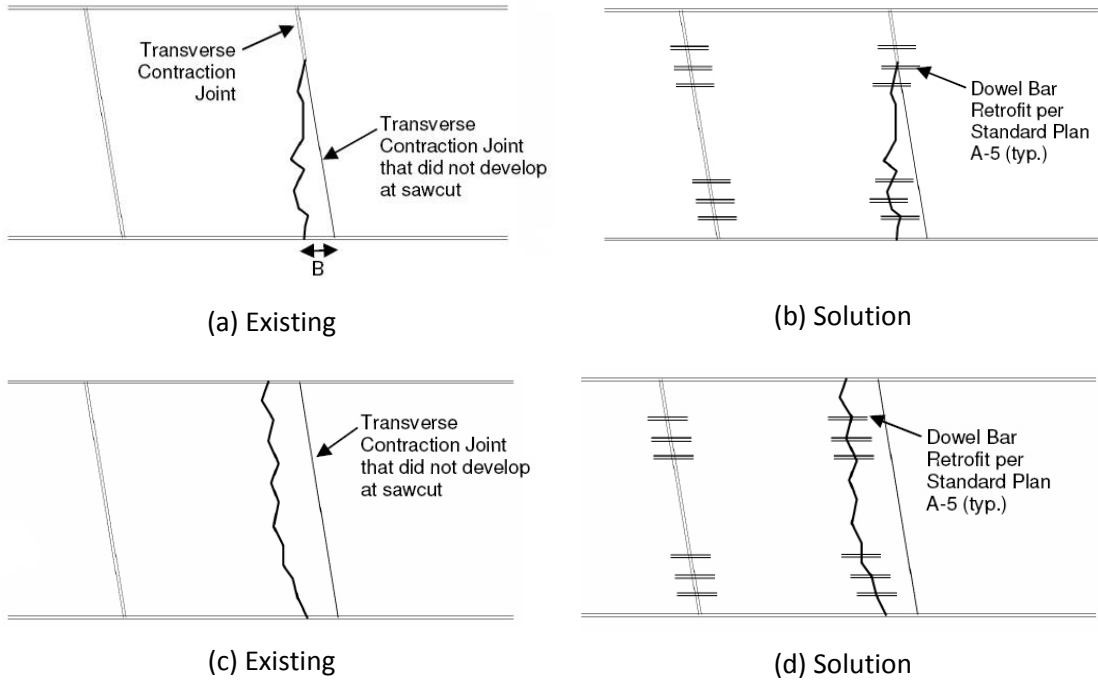
Figure 3 Working transverse crack.

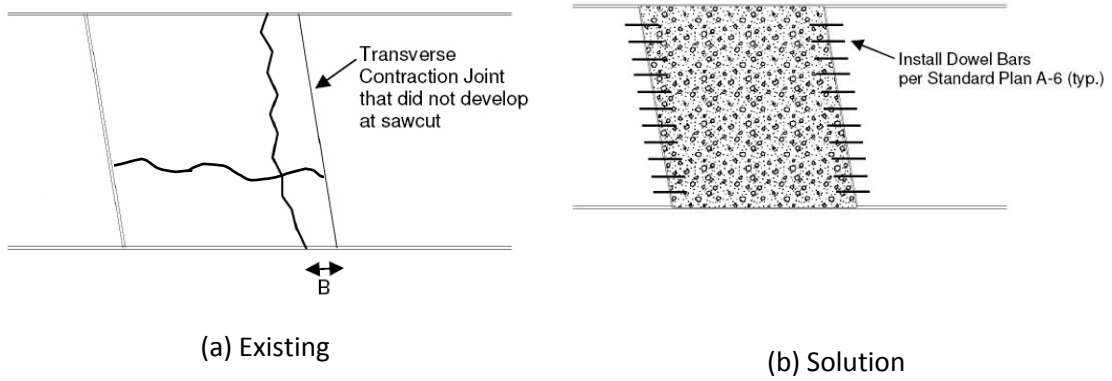
Figure 4 Multi cracked (two or more) and settled (> 1/2 inch) slab.

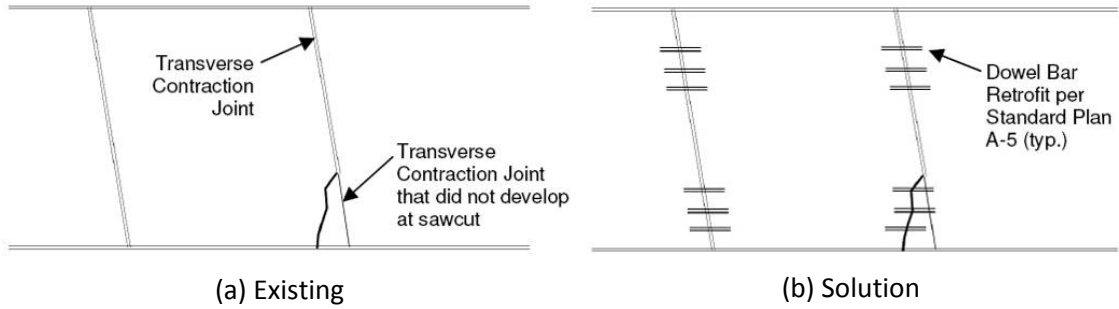
Figure 5 Working corner crack.

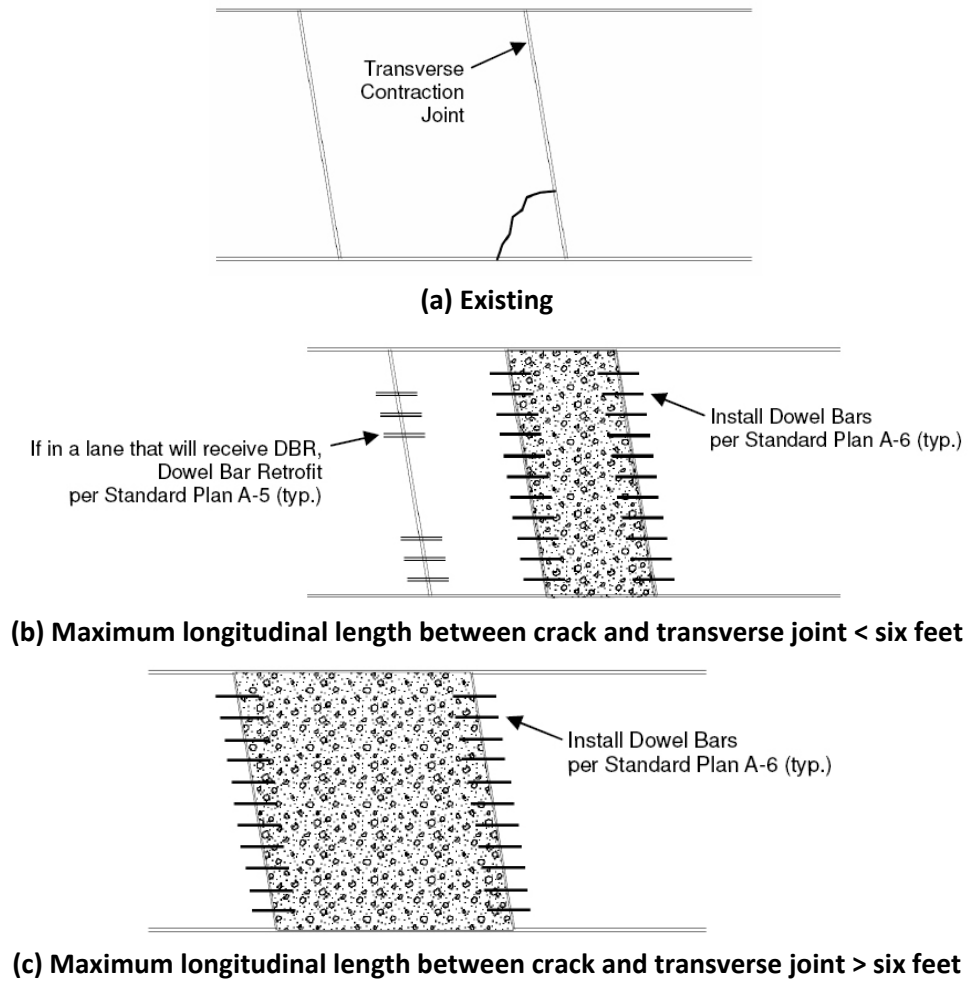
Figure 6 Corner crack.

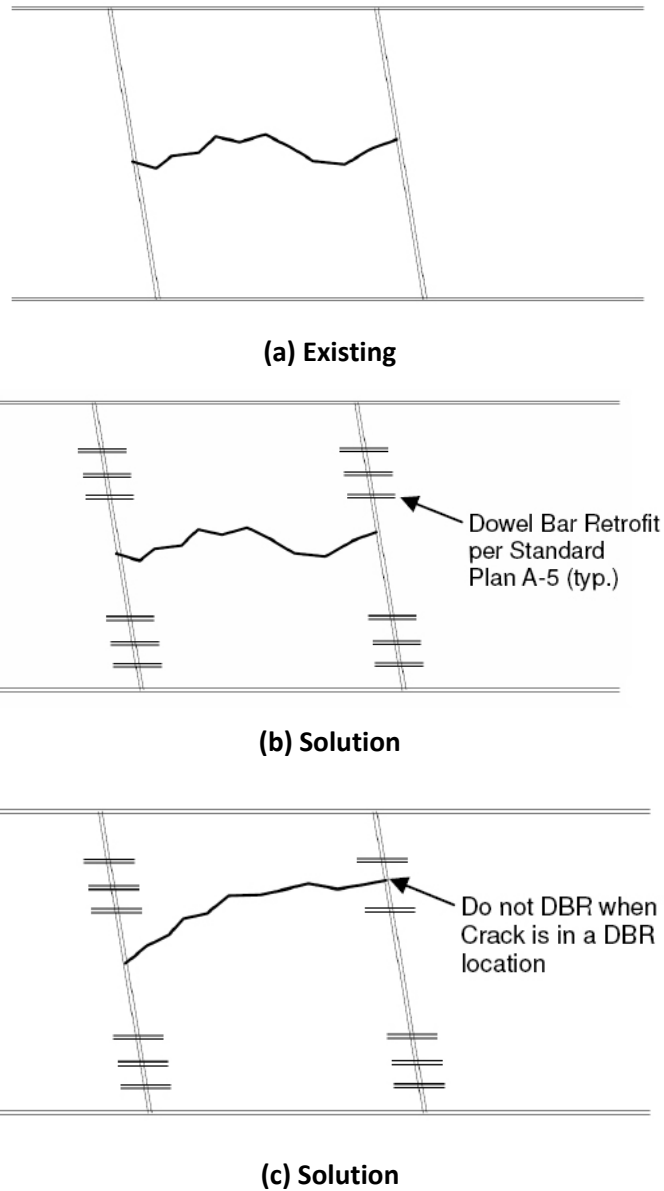
Figure 7 Longitudinal crack.

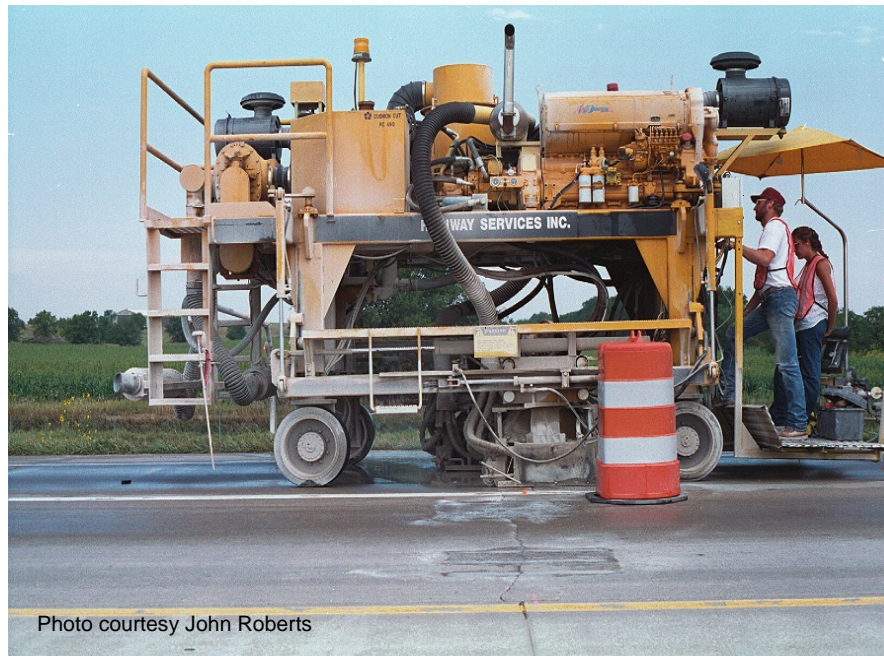
Figure 8 Cutting equipment for six dowel bar slots per joint.

Figure 8 illustrates equipment that can saw cut six dowel bar slots in one pass. This device is very effective in cutting both non skewed and skewed transverse joints. This device is also effective in cutting dowel bar slots on transverse cracks, depending on angle of crack skew.

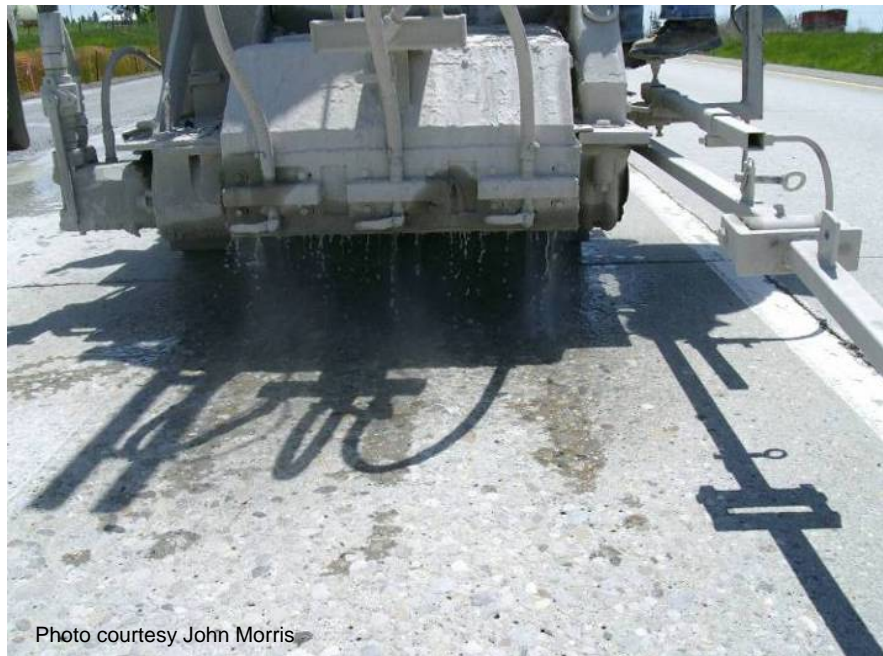
Figure 9 Cutting equipment for three dowel bar slots per wheelpath.

Figure 9 and Figure 10 shows the equipment for cutting three dowel bar slots per wheelpath. This equipment is effective on non-skewed and skewed joints and transverse cracks.

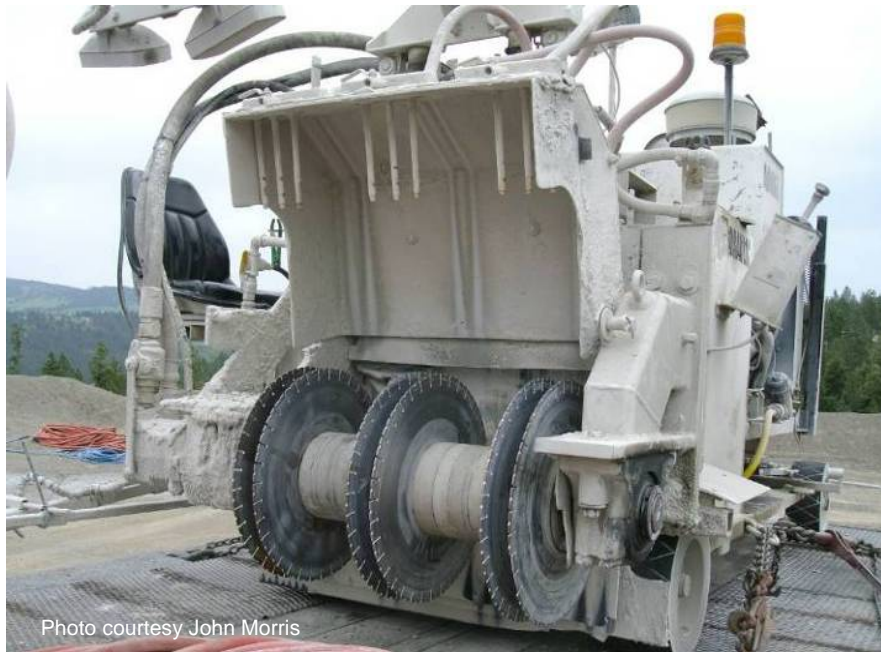
Figure 10 Diamond blades and spacing for three dowel bar slots per wheelpath.

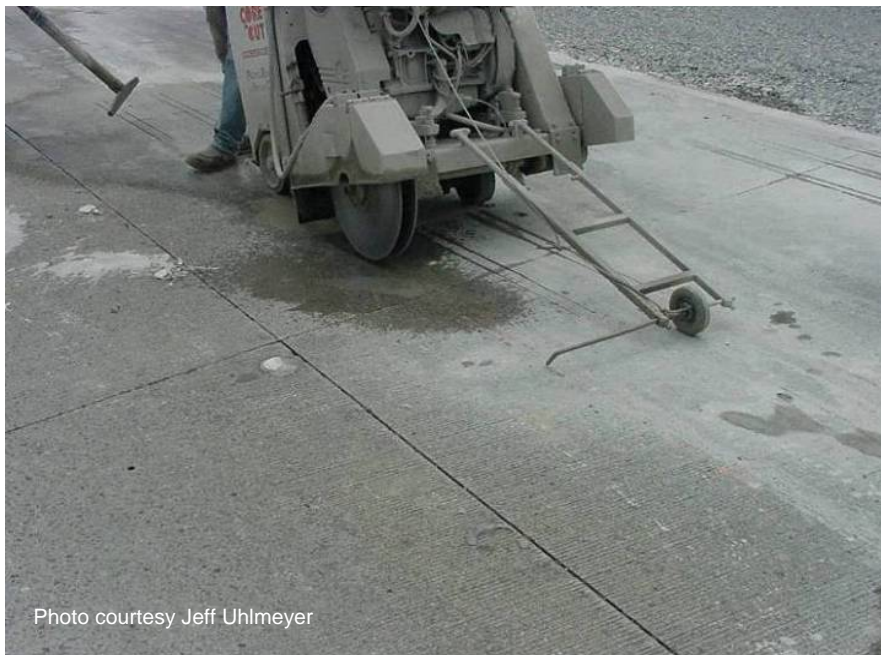
Figure 11 Cutting equipment for one dowel bar slot at a time.

Figure 11 illustrates equipment to saw cut a single dowel bar slot.

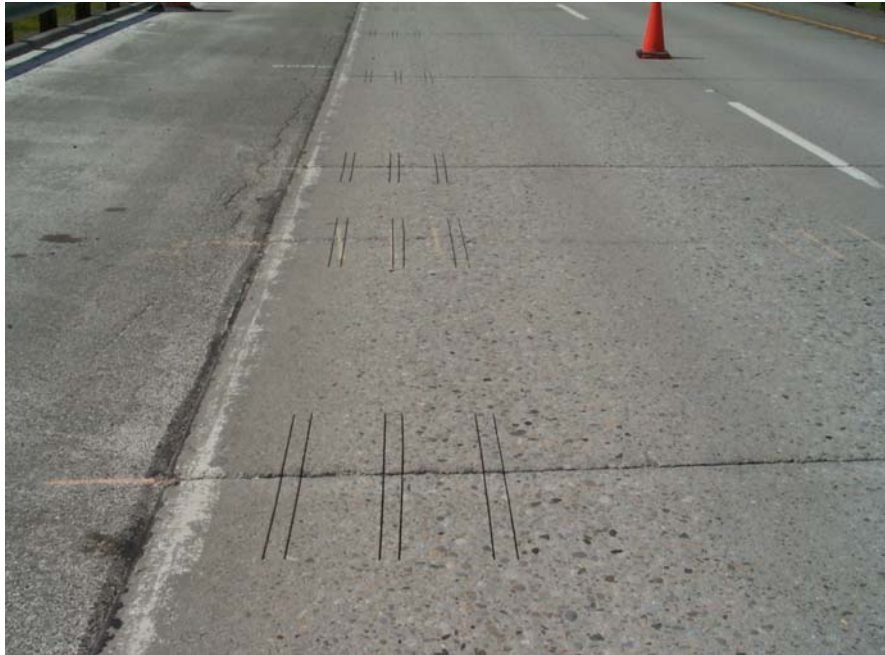
Figure 12 Cut dowel bar slots on non-skewed transverse joint.

Figure 12 illustrates the completed product from the sawcutting operation.

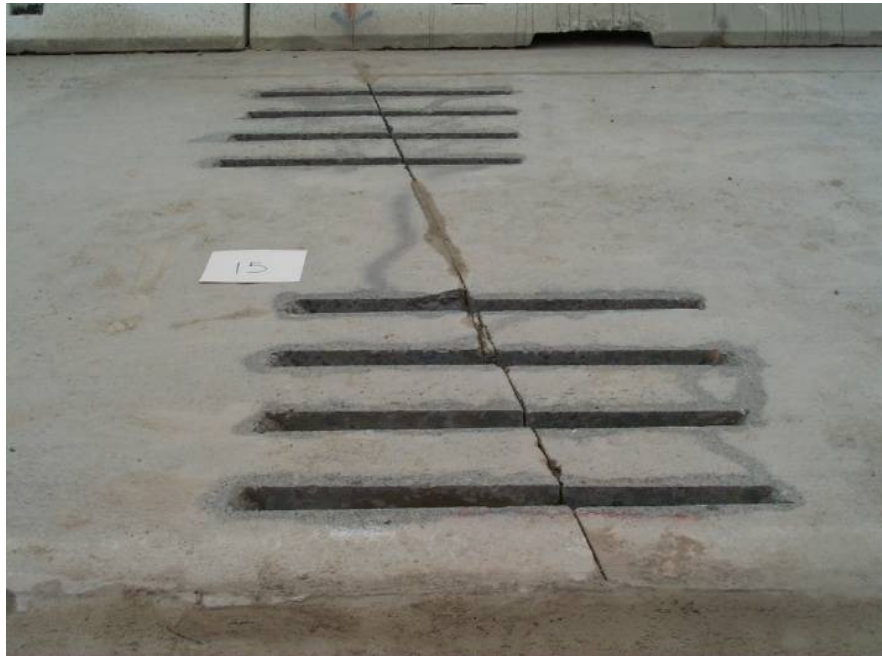
Figure 13 Dowel bar slots on a skewed transverse joint.

For skewed joints, when using sawcutting equipment that is capable of cutting three or more dowel bar slots per wheelpath or six dowel bar slots per joint (in one pass), dowel bar slots should be cut with sufficient length (Figure 13) to allow the dowel bar retrofit assembly to be centered over the joint (equal length of dowel bar on either side of the joint).

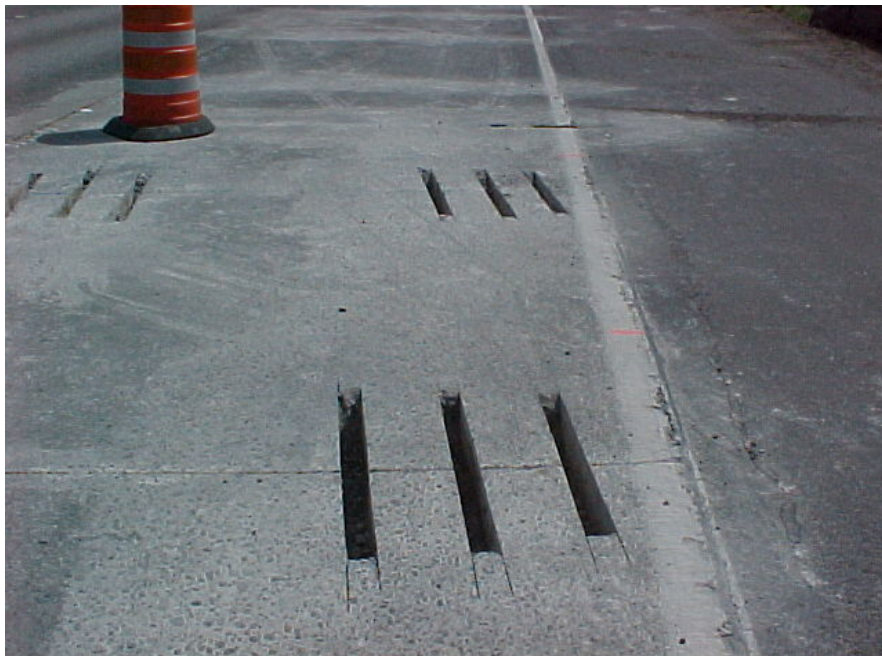
Figure 14 Dowel bar slots incorrectly cut on skewed joints.

Figure 14 illustrates dowel bar slots that have not been correctly sawcut on a skewed joint. In this case, the dowel bar slots were cut perpendicular to the skewed joint (as is necessary for non-skewed joints) rather than parallel to centerline.

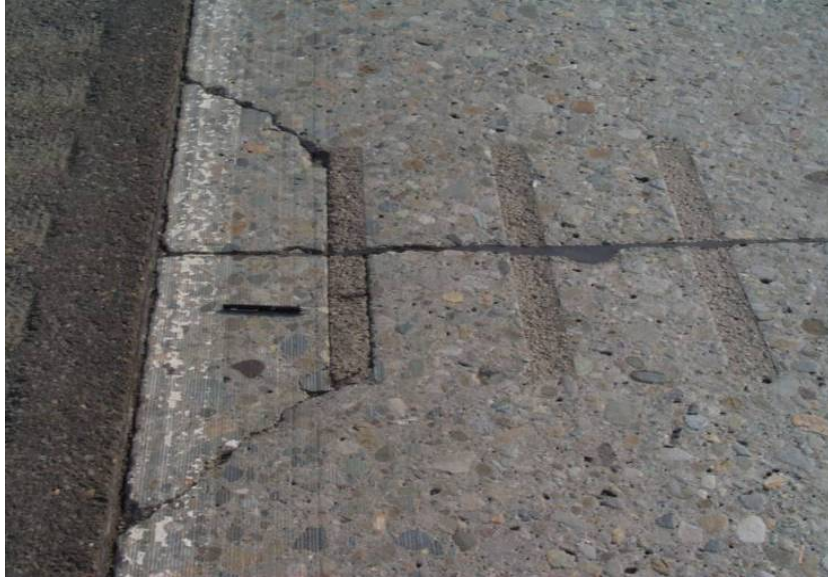
Figure 15 Distress due to dowel bar slot cut and/or chipped too deep.

Slots cut deeper than necessary can contribute to corner cracking (Figure 15). Patching material failure and the potential of the jackhammer punching through the bottom of the dowel bar slot may also occur. The Contractor/Inspector should physically measure (Figure 16) the dowel bar retrofit assembly height (including chairs) to ensure proper sawcut depth.

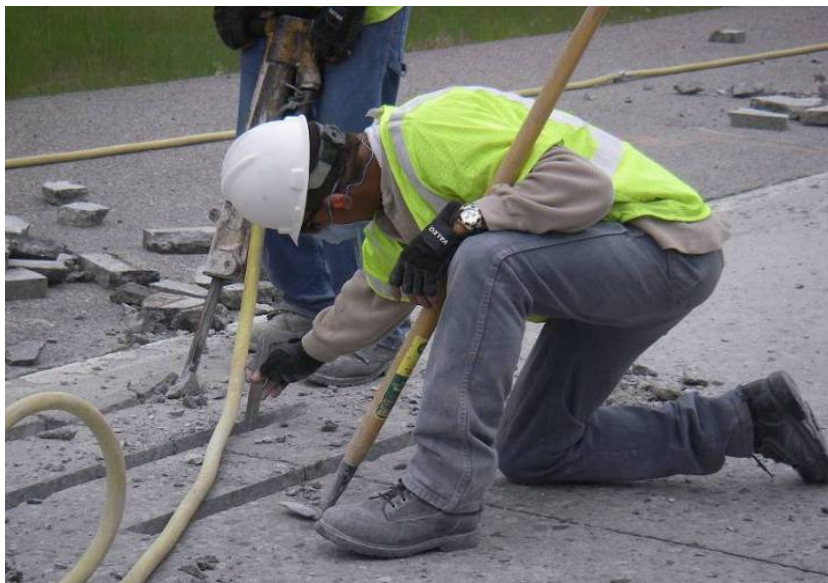
Figure 16 Check depth of dowel bar slot.

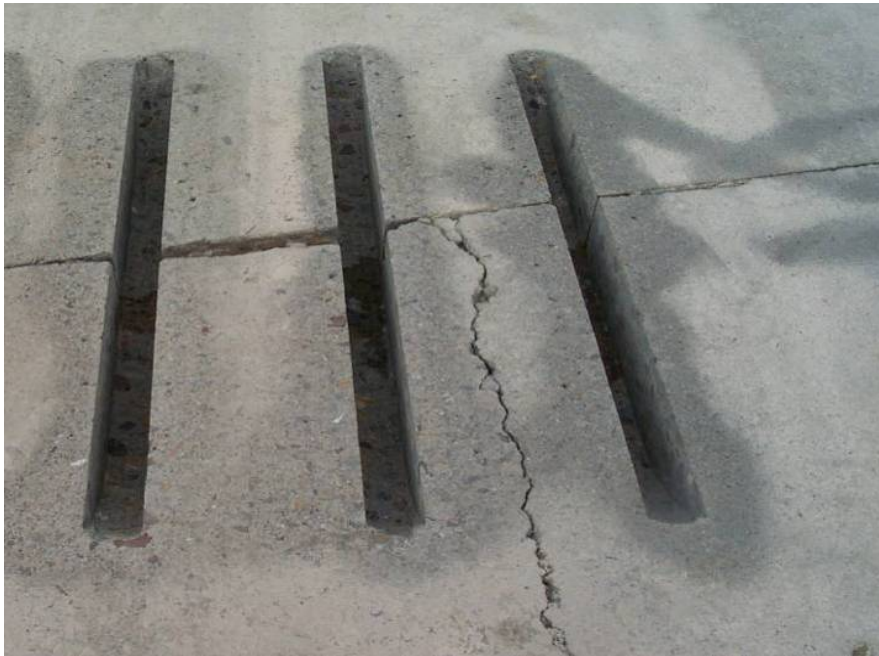
Figure 17 Dowel bar slots aligned to miss an existing longitudinal crack.

Dowel bar slots should be aligned to miss (Figure 17) any existing longitudinal crack. Depending on the wander of the longitudinal crack, dowel bar slots could also be eliminated (Figure 18). If the longitudinal crack was located in the right wheelpath, completely eliminating all dowel bar slots would not be recommended. In this instance, it may be best to place as many dowel bar slots as possible without intersecting the longitudinal crack.

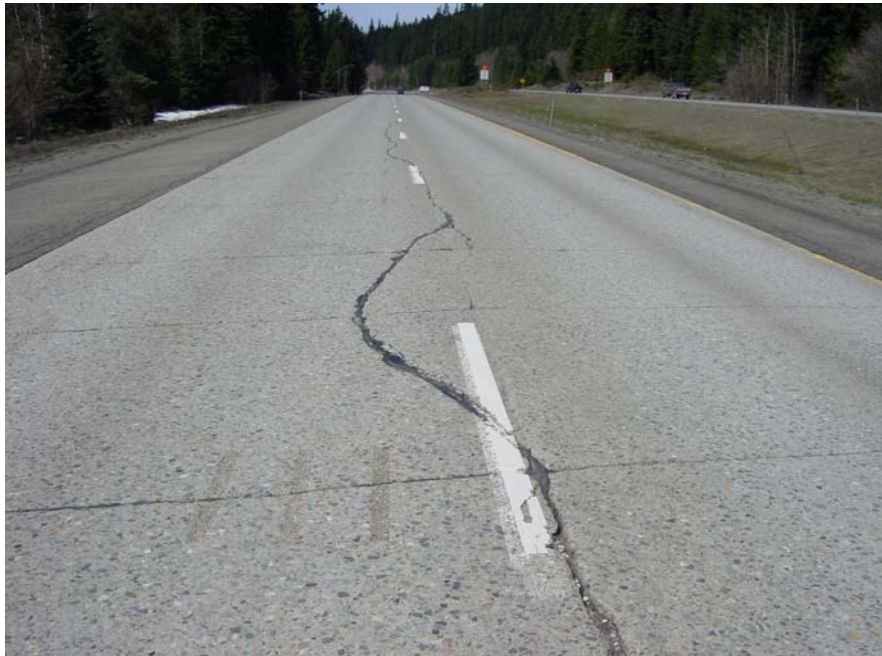
Figure 18 Left wheelpath dowel bar slots not installed to avoid existing longitudinal crack.

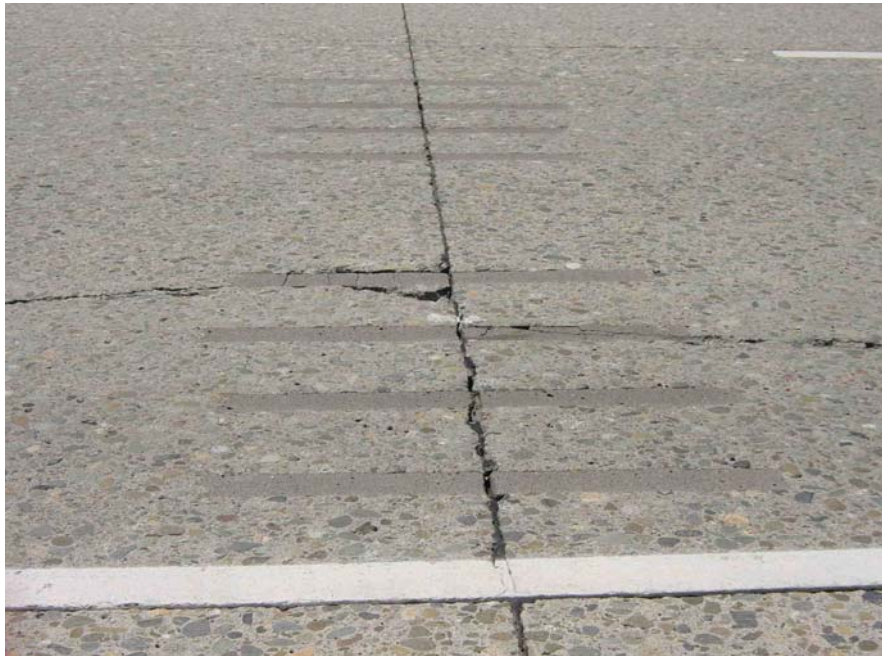
Figure 19 Failure of dowel bar slot placed over existing longitudinal crack.

Figure 19 and Figure 20 illustrate instances where the dowel bar slot was not placed to miss the existing longitudinal crack resulting in failure of the patching material. Dowel bar slots placed over a longitudinal crack will fail within a very short period of time (< 12 months). The failure mechanism is typically debonding, cracking and spalling of the concrete patching material. Shifting dowel bar slots, three to four inches, will prevent this distress while still providing the required load transfer. If a gang saw is used, dowel bar slots may be sawed but not retrofitted, any non-retrofitted sawcuts should be cleaned and sealed with an epoxy resin.

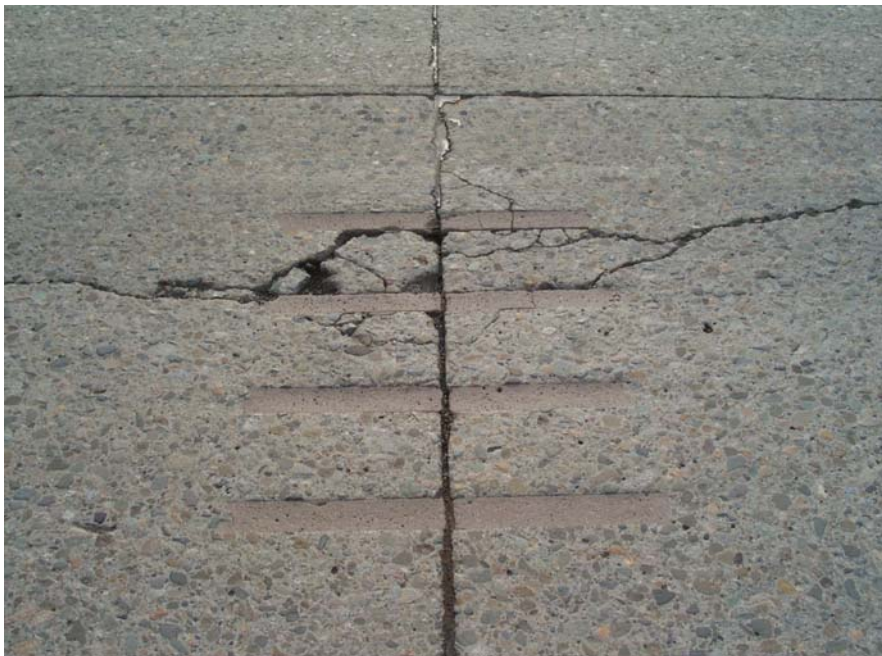
Figure 20 Severe failure of dowel bar slot placed over existing longitudinal crack.

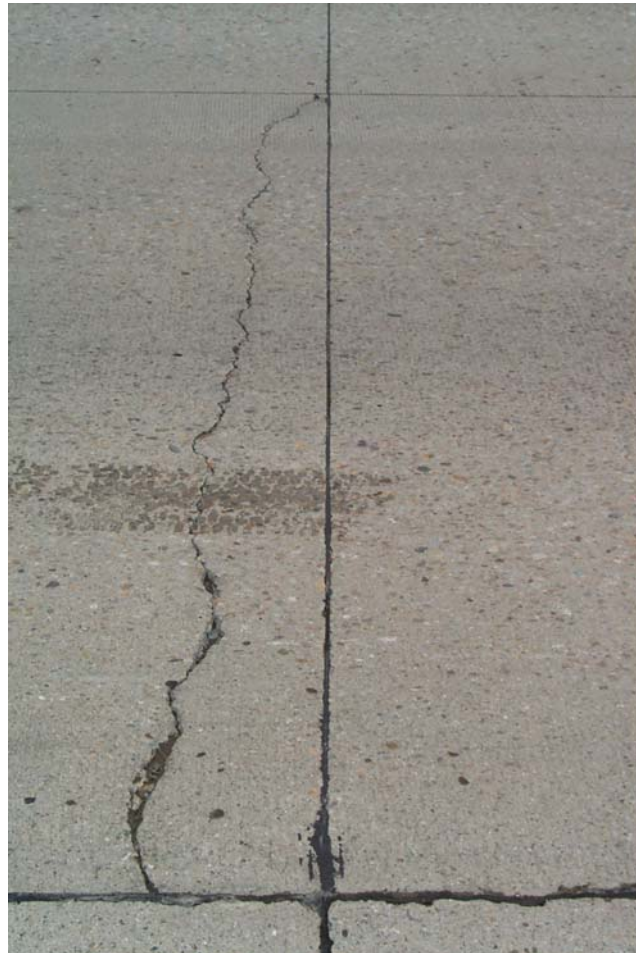
Figure 21 Transverse crack is functioning as the working joint.

All existing transverse joints and cracks should be dowel bar retrofitted. Figure 21 shows a non-working joint (narrow joint opening and excellent joint sealant condition after being in-

service for more than 20 years with no maintenance) and a transverse crack that is functioning as the working joint. In this case, the crack should be dowel bar retrofitted and not the joint.

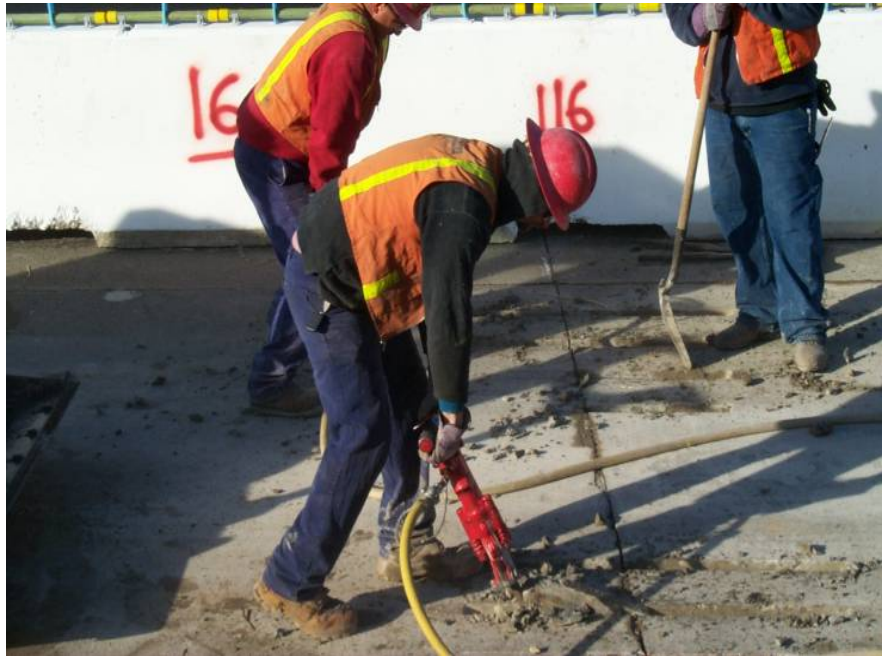
Figure 22 Maintain jackhammer at no more than a 45-degree angle.

The existing concrete should be removed from the dowel bar slot using jackhammers weighing 30 pounds or less. Jackhammers should be operated at a 45 degree angle or less (Figure 22 through Figure 24). Jackhammers operated in a vertical position can punch through the bottom of the dowel bar slot.

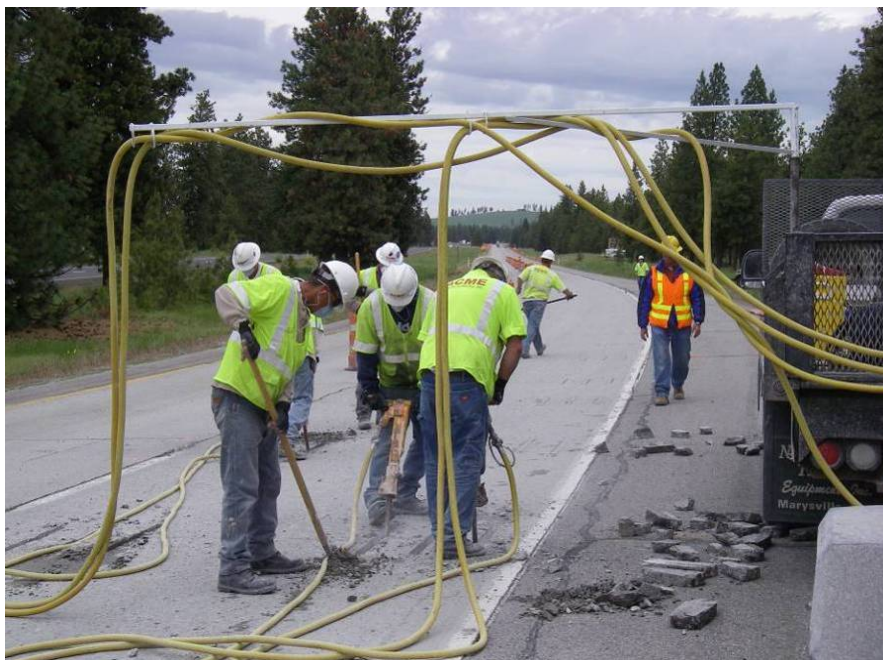
Figure 23 Jackhammer operation.

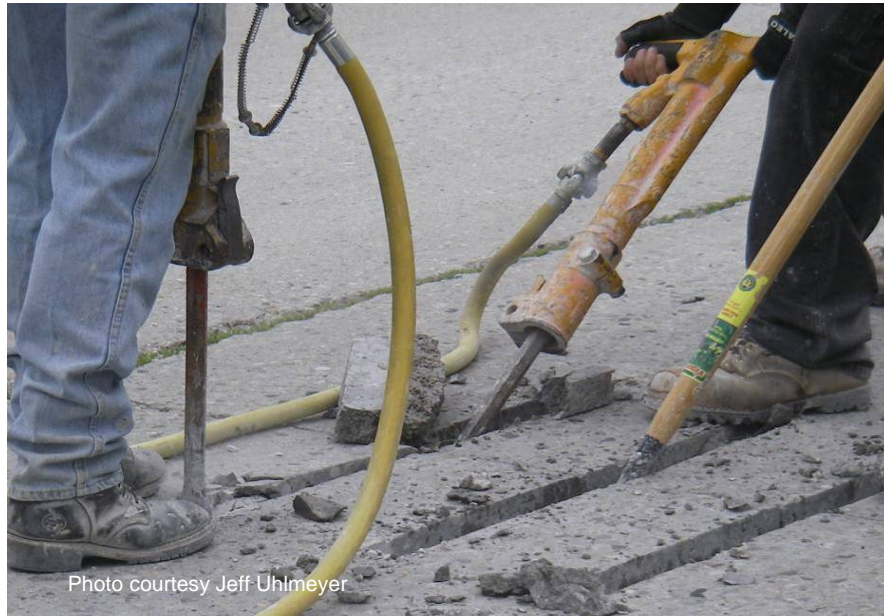
Figure 24 Removing concrete within dowel bar slot.

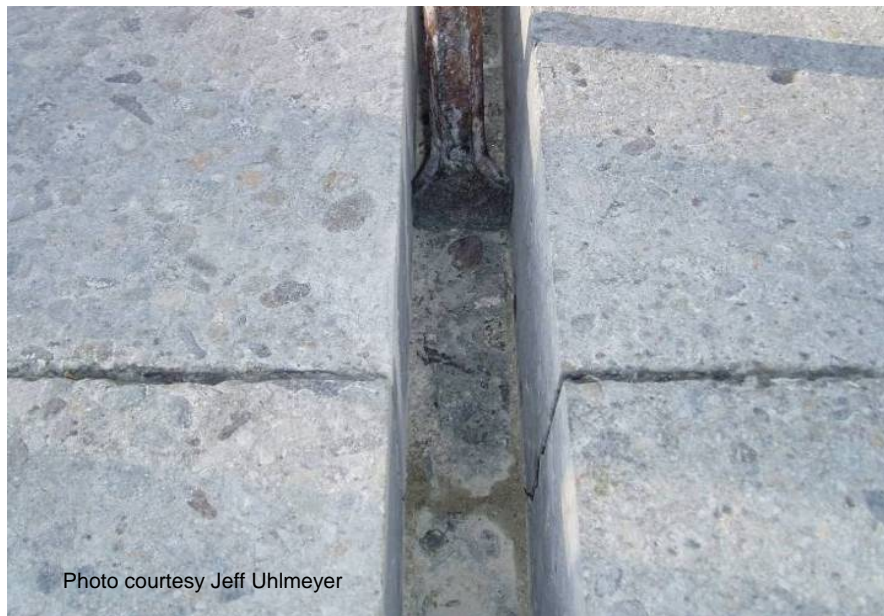
Figure 25 Leveling the bottom of the dowel bar slot.

Leveling of the dowel bar slot bottom (Figure 25) helps ensure that the dowel bar will meet alignment tolerances. This work should be conducted with a 15-pound or lighter jackhammer.

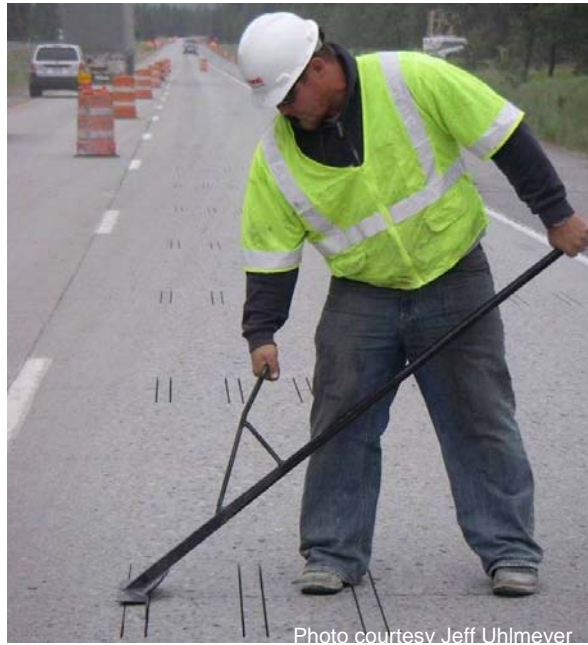
Figure 26 Breaker bar.

A breaker bar Figure 26 and Figure 27 may be used to expedite the jackhammer removal operation of the concrete within the dowel bar slot.

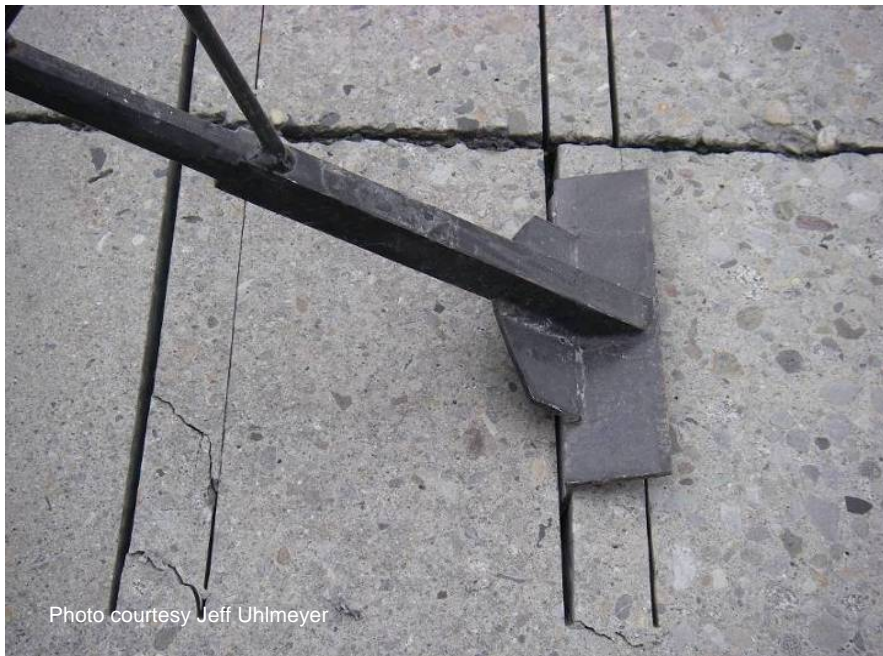
Figure 27 Close-up of breaker bar.

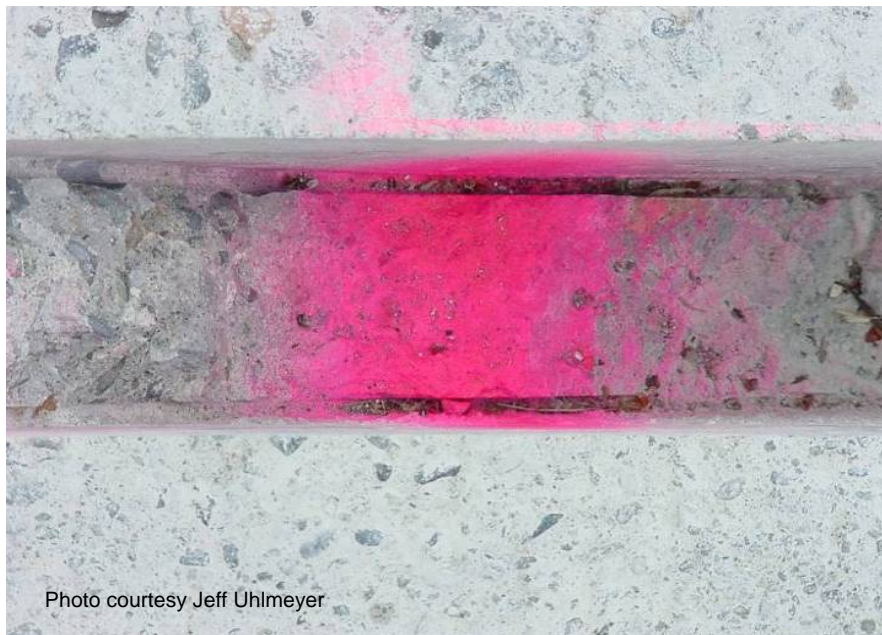
Figure 28 Concrete not fully removed from the bottom of the dowel bar slot.

Figure 28 illustrates insufficient removal of the existing concrete from the bottom of the dowel bar slot. This high point may result in a skew in the horizontal position of the dowel bar beyond that which is allowed by specification tolerances. If this skew is severe, dowel bar lockup and eventual failure of the patching material may occur. Slot bottom should be leveled using a lightweight (< 15 pound) jackhammer.

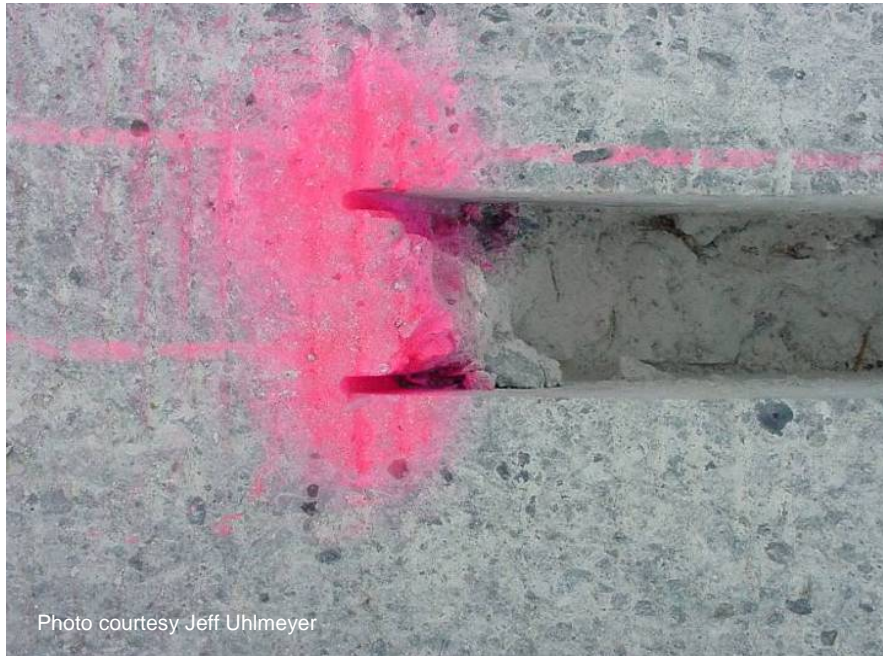
Figure 29 Concrete not sufficiently removed from the end of the dowel bar slot.

Figure 29 illustrates insufficient removal of the existing concrete at the end of the dowel bar slot. Improper concrete removal could result in insufficient length for the dowel bar to sit level in the dowel bar slot and may not allow for sufficient patching material around the dowel bar. Though this may not be extreme in this case, spalling at the end of the dowel bar slot may occur due to difficulty in obtaining patching material consolidation.

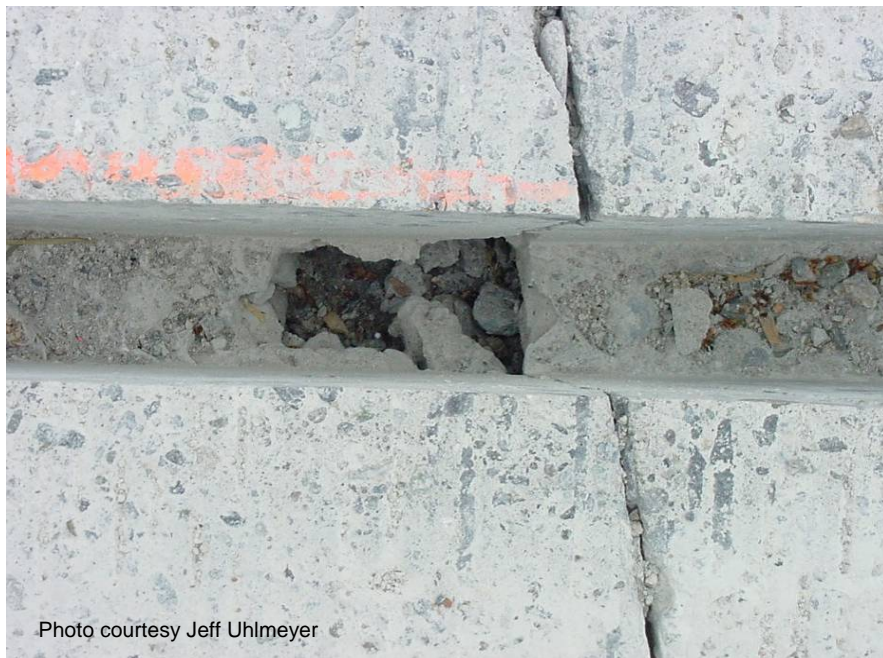
Figure 30 Jackhammer punching through the bottom of the dowel bar slot.

Figure 30 illustrates a situation where the jackhammer operation caused failure of the bottom of the dowel bar slot. This may have occurred due to operating the jackhammer at an angle greater than 45 degrees, the dowel bar slot was sawcut to deep leaving an insufficient depth of concrete between the dowel bar slot bottom and the bottom of the concrete slab, which was easily broken during the jackhammering process or the use of jackhammers weighing more than 30 pounds.

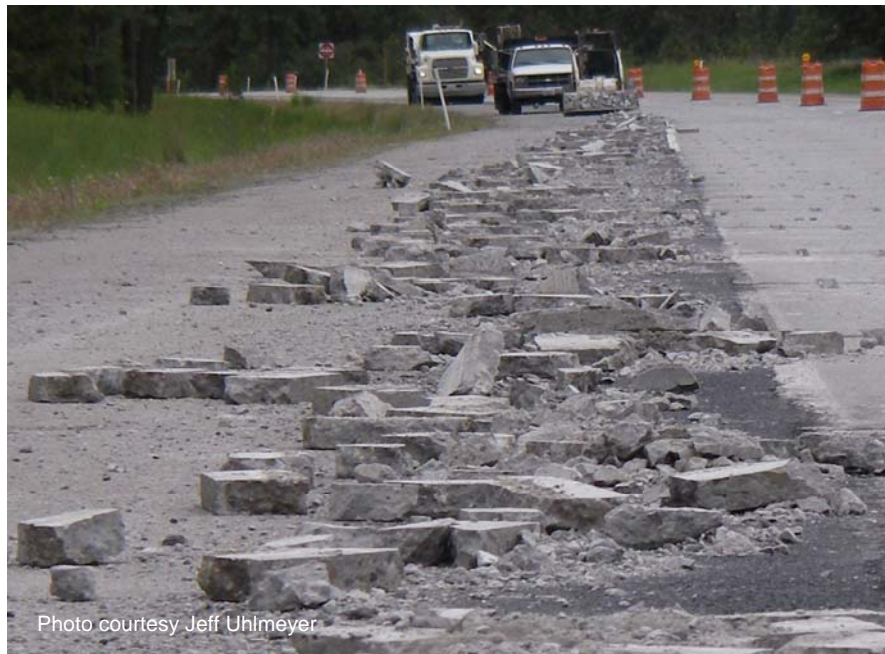
Figure 31 Debris from the jackhammering process.

Removal of the dowel bar slot debris can be quite laborious. The use of a small loader can aid in the clean-up operation (Figure 31 through Figure 34).

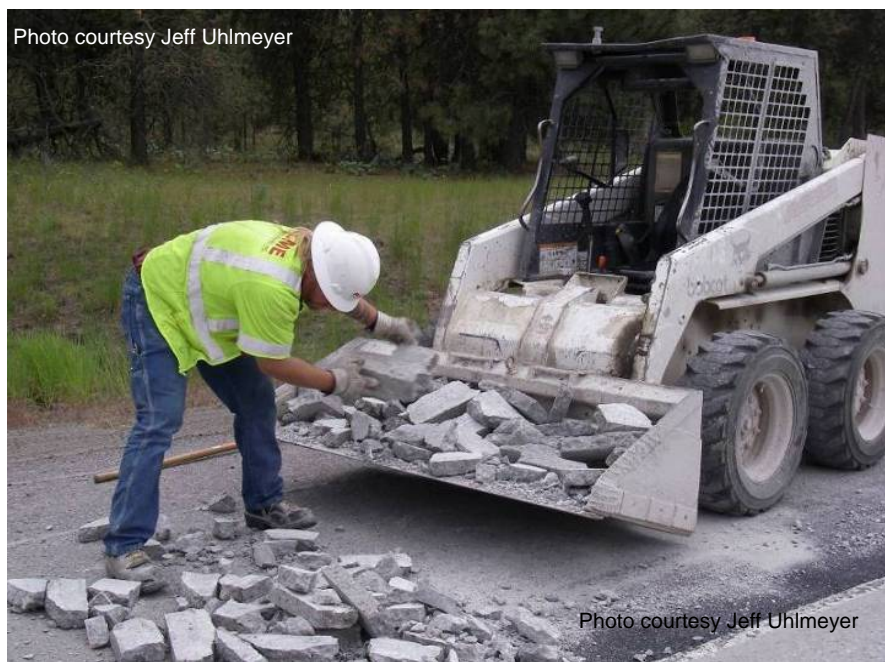
Figure 32 Debris removal.

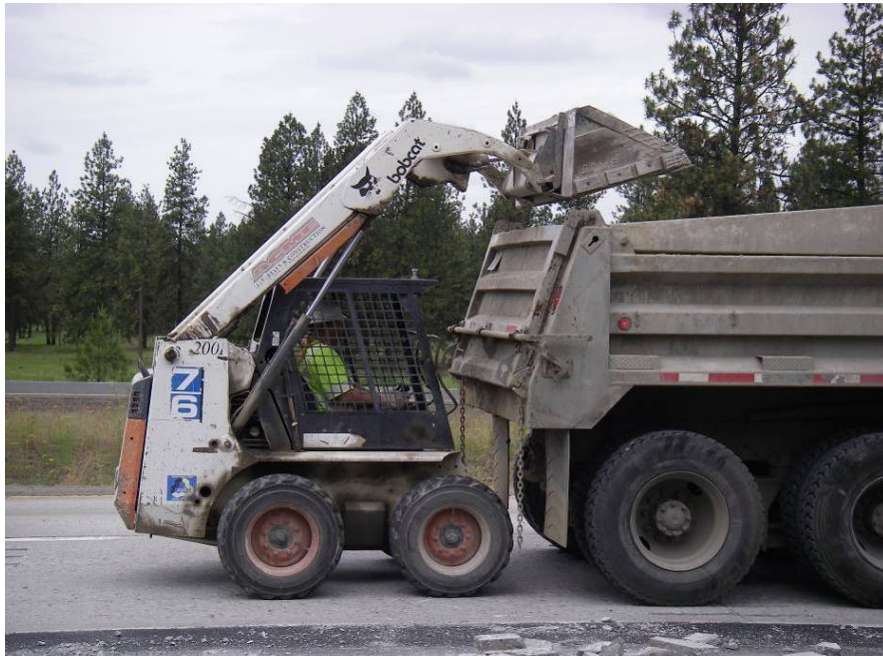
Figure 33 Loading debris into dump truck.

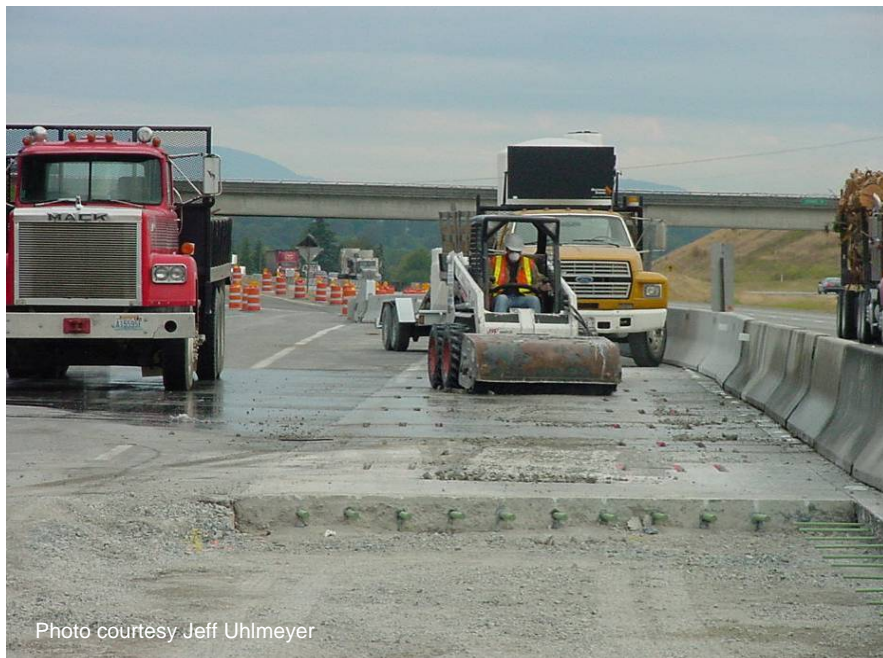
Figure 34 Sweeping debris from roadway.

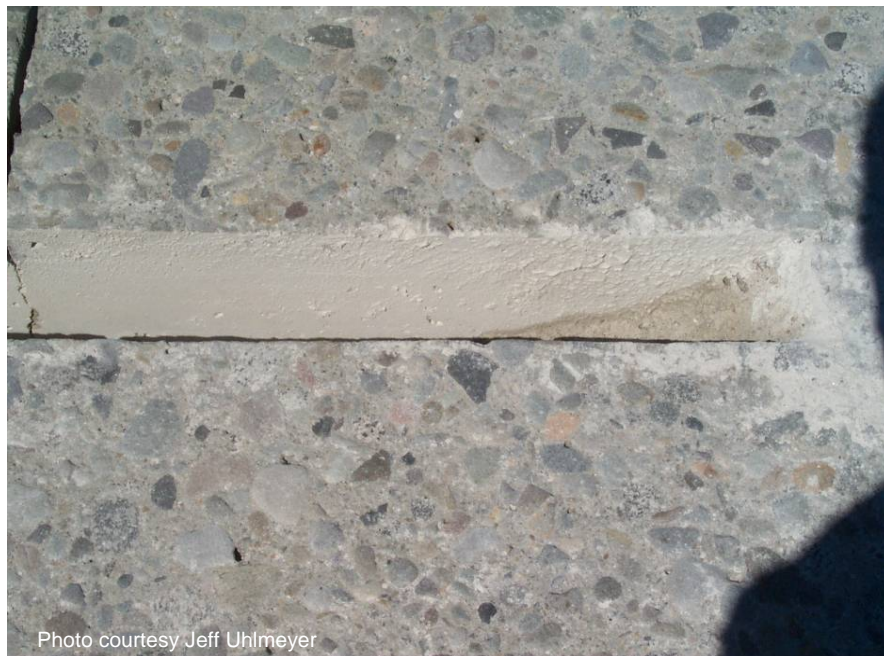
Figure 35 Sawcut blade residue on slot walls.

After completion of the sawcutting and concrete removal process, debris and saw blade slurry exists in the dowel bar slot (Figure 35). This material must be removed prior to installation of the dowel bar retrofit assembly. Insufficient cleaning of the dowel bar slot will prohibit adherence of the patching material to the existing concrete, which will result in a bonding failure between the patching material and the existing concrete.

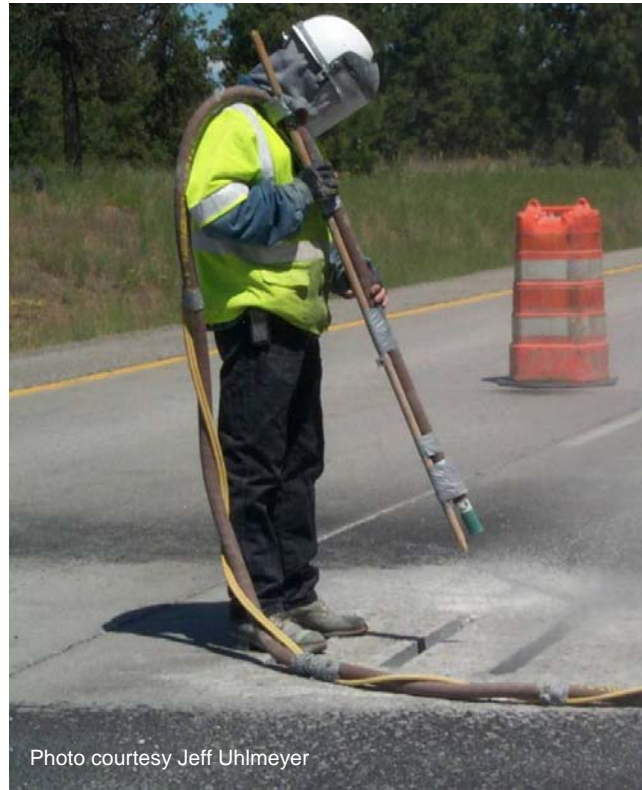
Figure 36 Cleaning dowel bar slot by shot blasting.

All exposed surfaces and cracks in the dowel bar slot should be sand blasted (Figure 36 and Figure 37) and cleaned to bare concrete to remove any diamond saw blade slurry or other debris. The dowel bar slot is considered to be clean when all debris and standing water has been removed from the dowel bar slot sides and bottom. The side of the dowel bar slot is considered clean when wiping the sides of the dowel bar slot, with a clean towel or hand, produces no residue.
