Dowel Bar Retrofit – Do's and Don'ts

WA-RD 576.2

March 2009

16. ABSTRACT This report documents construction and inspection guidelines for the successful construction of a dowel bar retrofit project.			
17. KEY WORDS Dowel bar retrofit, concrete rehabilitation, construction techniques		18. DISTRIBUTION STATEMENT No restrictions. This document is available to the public through the National Technical Information Service, Springfield, VA 22616

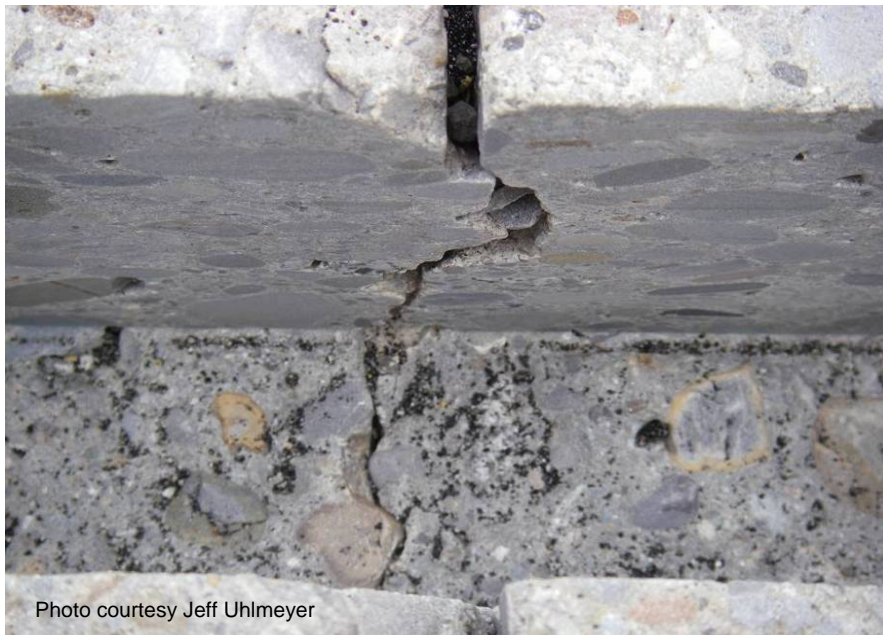
Figure 37 Dowel bar slot after shot blasting.

All exposed surfaces and cracks in the dowel bar slot should be sand blasted (Figure 36 and Figure 37) and cleaned to bare concrete to remove any diamond saw blade slurry or other debris. The dowel bar slot is considered to be clean when all debris and standing water has been removed from the dowel bar slot sides and bottom. The side of the dowel bar slot is considered clean when wiping the sides of the dowel bar slot, with a clean towel or hand, produces no residue.

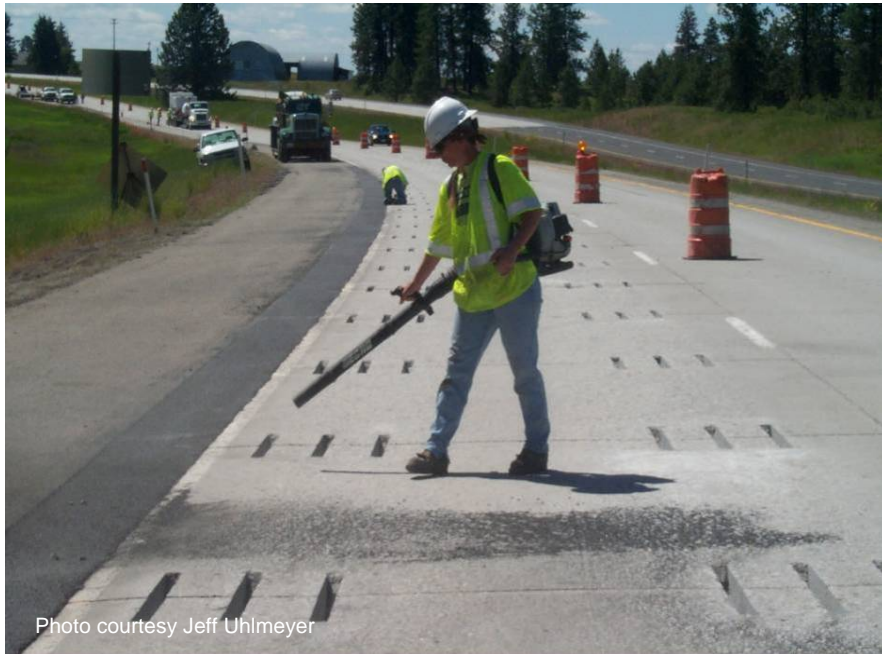
Figure 38 Cleaning shot blasting debris from roadway.

Compressed air (Figure 38 through Figure 40) may also be used to remove debris, water and slurry from the sides and the bottom of the dowel bar slots.

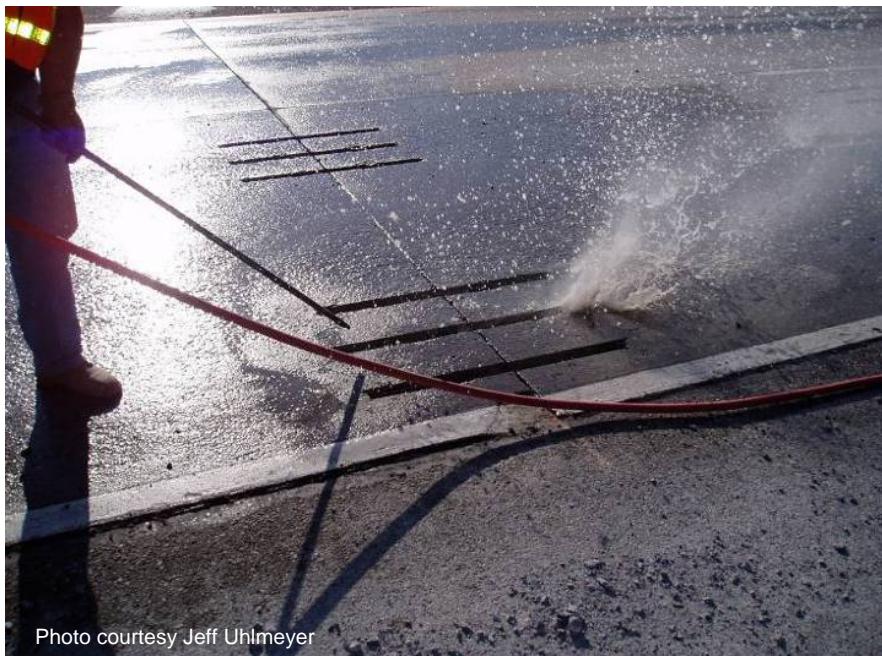
Figure 39 Removing water and other debris with compressed air.

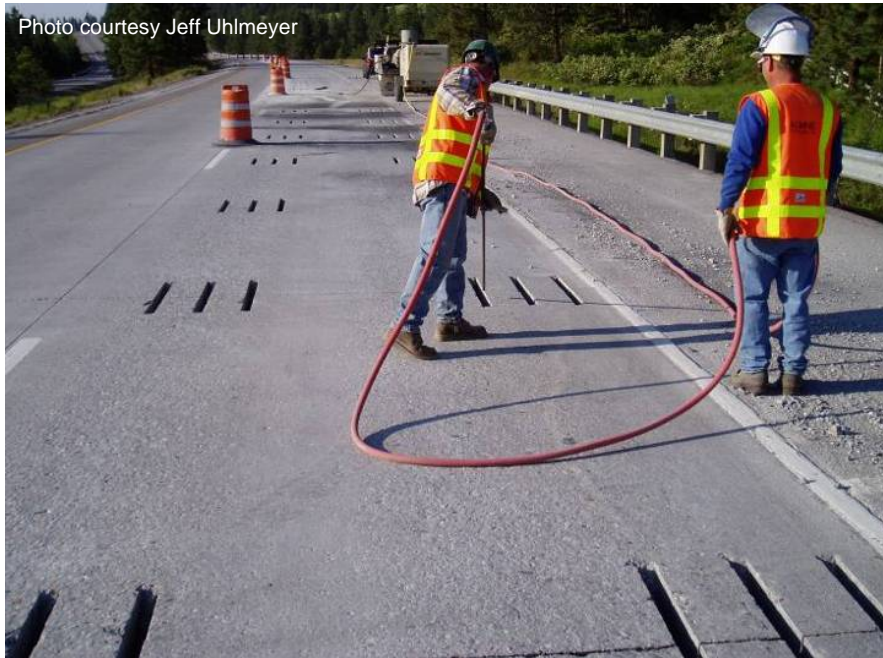
Figure 40 Cleaning dowel bar slots with compressed air.

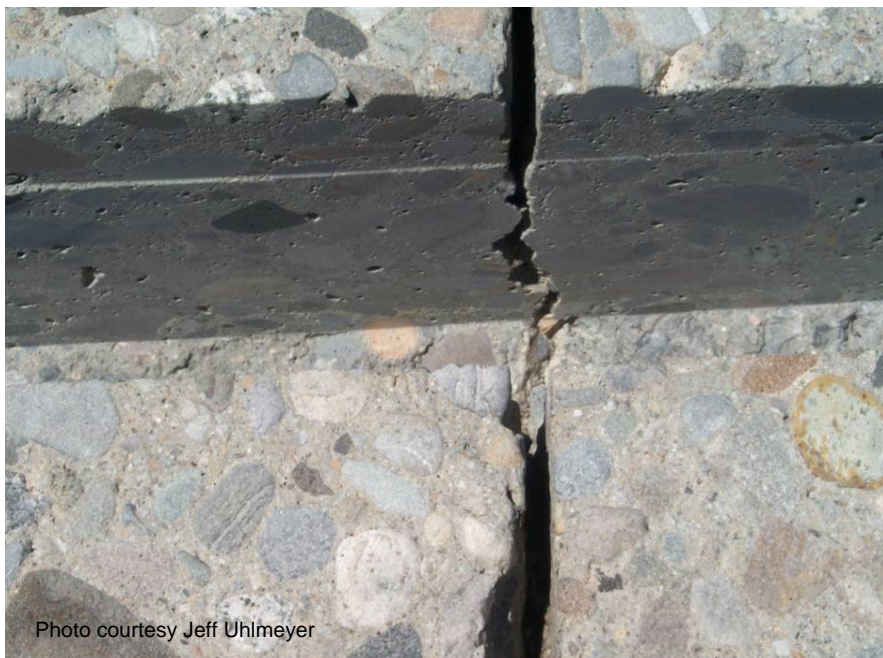
Figure 41 shows a properly cleaned dowel bar slot.

Figure 41 Cleaned dowel bar slot.

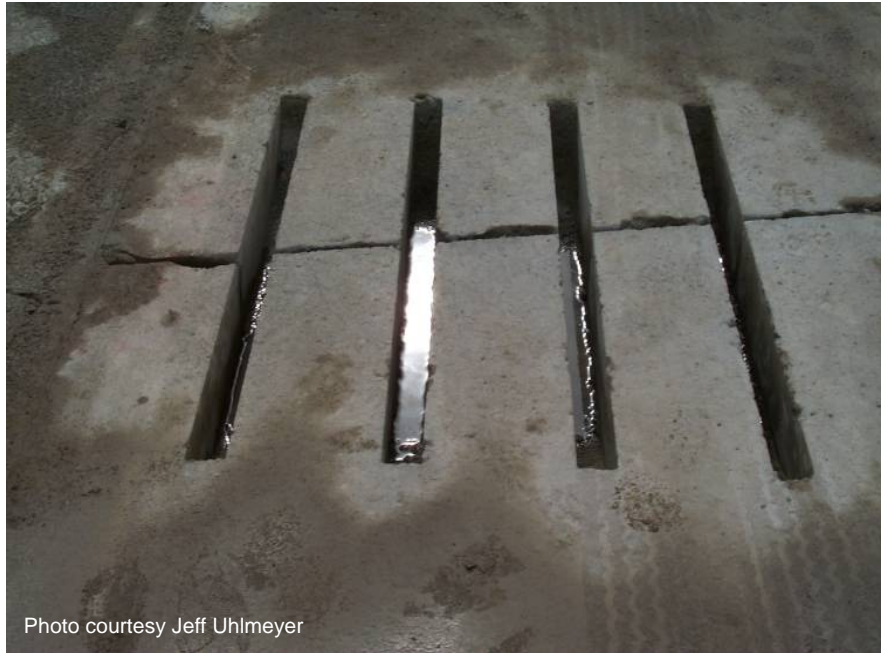
Removal of debris and slurry residue can be challenging if water is present in the dowel bar slot. If water is present (Figure 42), slurry residue is redistributed to the bottom or sides of the dowel bar slots and should be removed by sandblasting or compressed air. More than one attempt at cleaning the dowel bar slot may be required to obtain the desired cleanliness.

Figure 42 Water must be removed prior to placement of patching material.

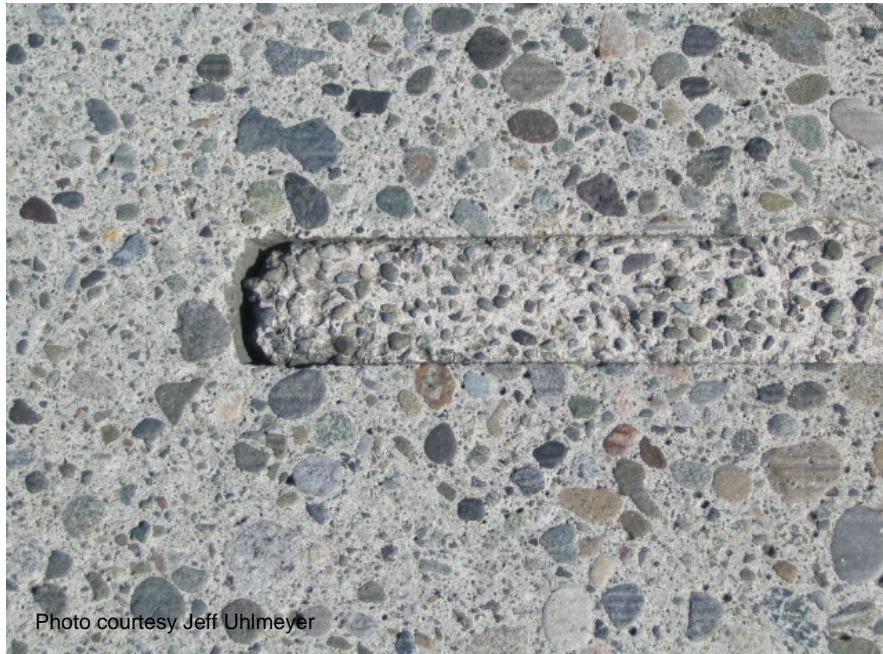
Figure 43 and Figure 44 shows debonding of the patching material from the dowel bar slot. This distress is typically related to inadequate cleaning of the dowel bar slot. Repair of this distress requires removal and replacement of the patching material.

Figure 43 Patching material bond failure.

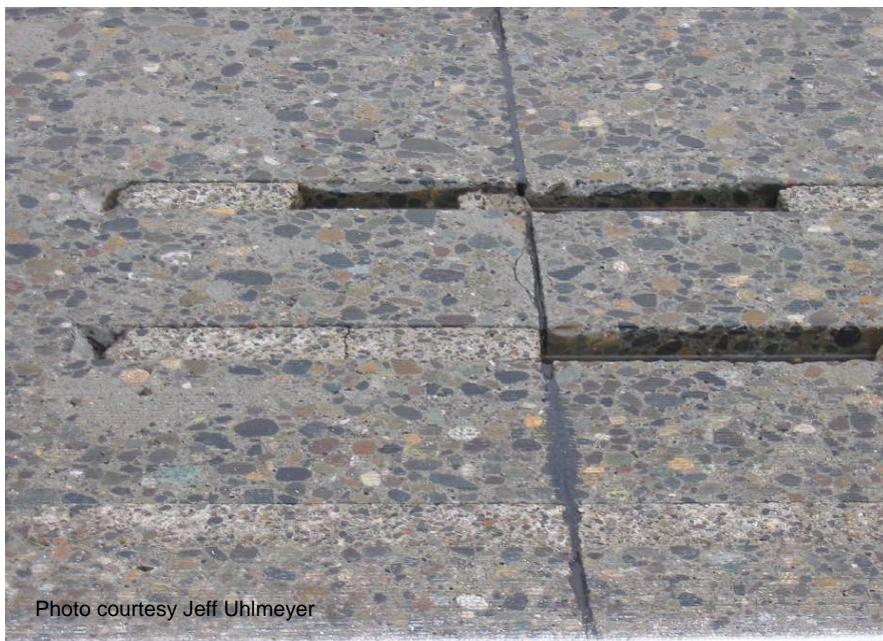
Figure 44 Severe patching material bond failure.

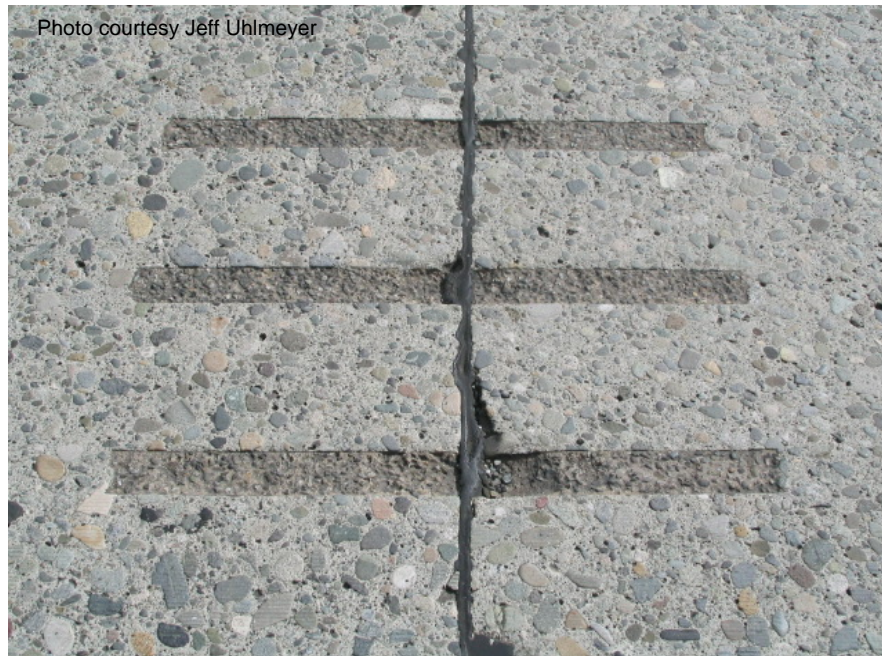
Figure 45 illustrates spalling of the patching material. Potential causes of this distress can be related to consolidation, lack of sufficient aggregate or opening too early to traffic. Figure 46

Figure 45 Spalling of patching material.

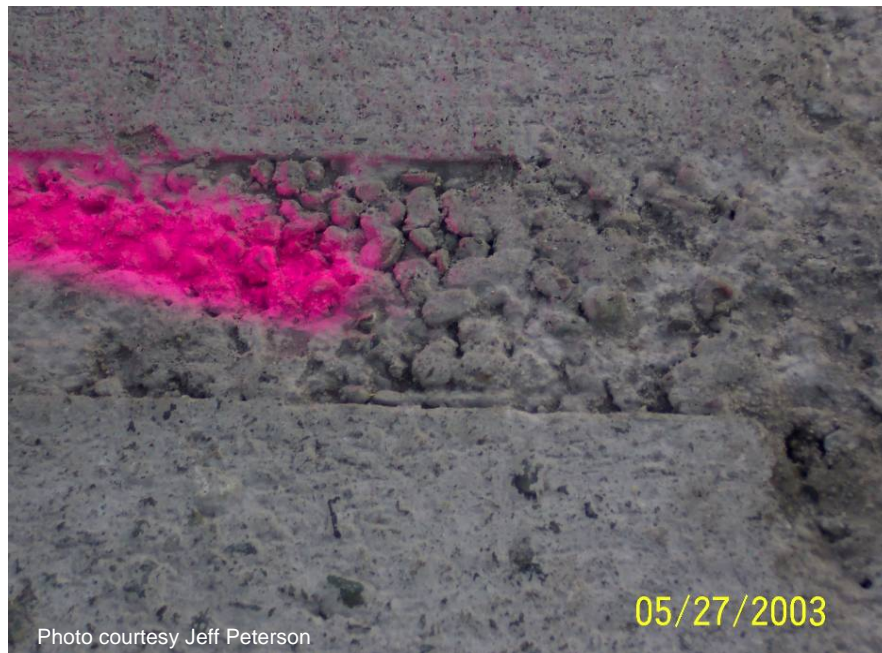
illustrates insufficient consolidation in the patching material. Repair, for both instances would include removal and replacement of two to three inches of the patching material.

Figure 46 Insufficient consolidation of patching material.

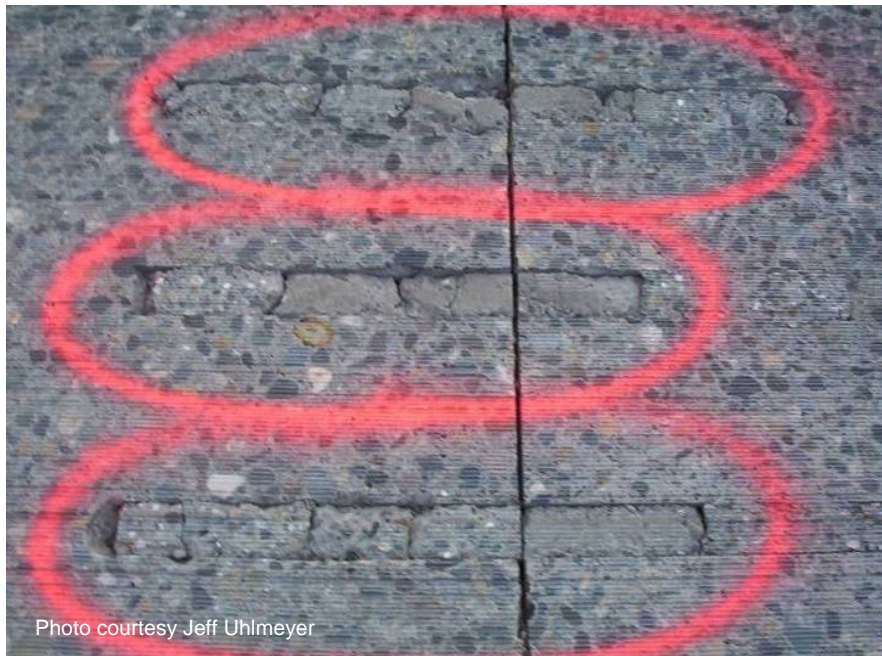
Figure 47 illustrates shrinkage cracking of the patching material. This type of cracking is repaired by removal and replacement of distressed patching material.

Figure 47 Shrinkage cracks of pour back material.

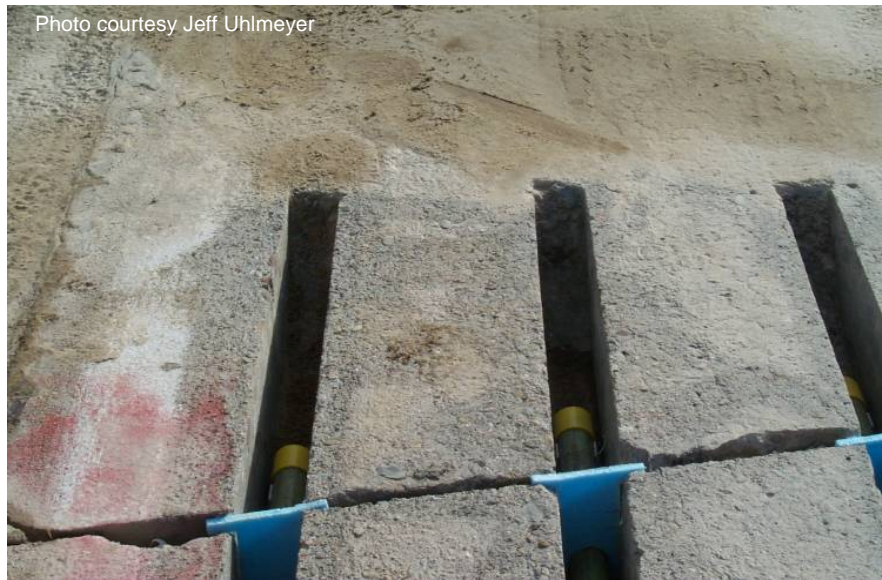
Debris should be removed a minimum of four feet from the dowel bar slots. This material can be reintroduced (Figure 48) into the dowel bar slot and may result in bonding issues.

Figure 48 Debris should be cleared to a sufficient distance to prevent intrusion.

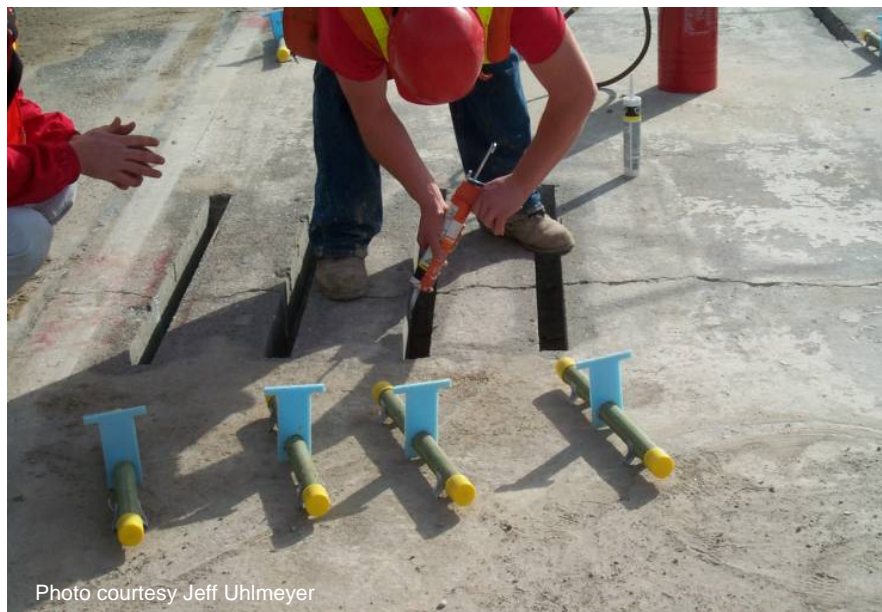
Transverse joints and cracks must be caulked (Figure 49 and Figure 50) within the dowel bar slot. Caulking material should not extend more than $\frac{1}{2}$ inch beyond either side of the joint or crack. The caulking material will prevent patching material from entering the joint/crack.

Figure 49 Caulking dowel bar slot sides and bottom.

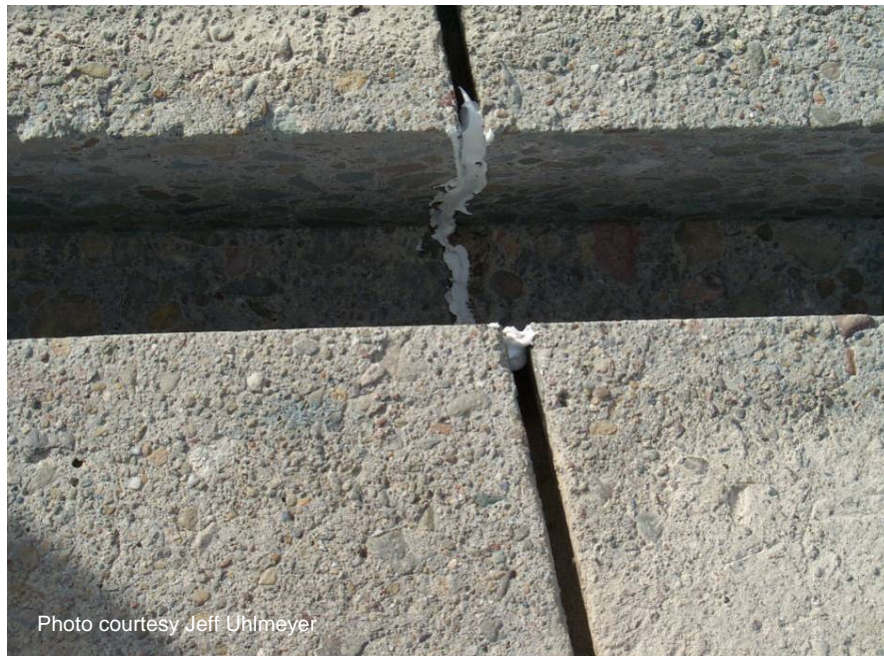
Figure 50 Caulked dowel bar slot.

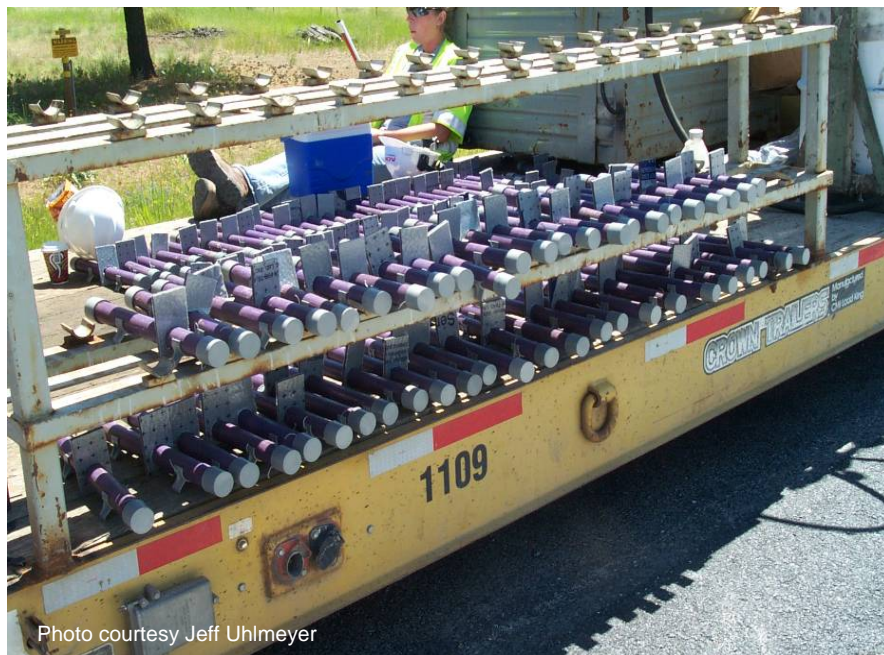
Figure 51 shows the assembled dowel bars, chairs, end caps and foam core boards on a flat bed trailer. Dowel bar retrofit assemblies are taken from the flat bed trailer, placed adjacent to the dowel bar slot locations (Figure 52 and Figure 53) and inserted into the dowel bar slot (Figure 54). Figure 55 shows the dowel bar retrofit assembly at a transverse joint location and Figure 56 and Figure 57 shows the dowel bar retrofit assembly at transverse cracks.

Figure 51 Dowel bar retrofit assemblies.

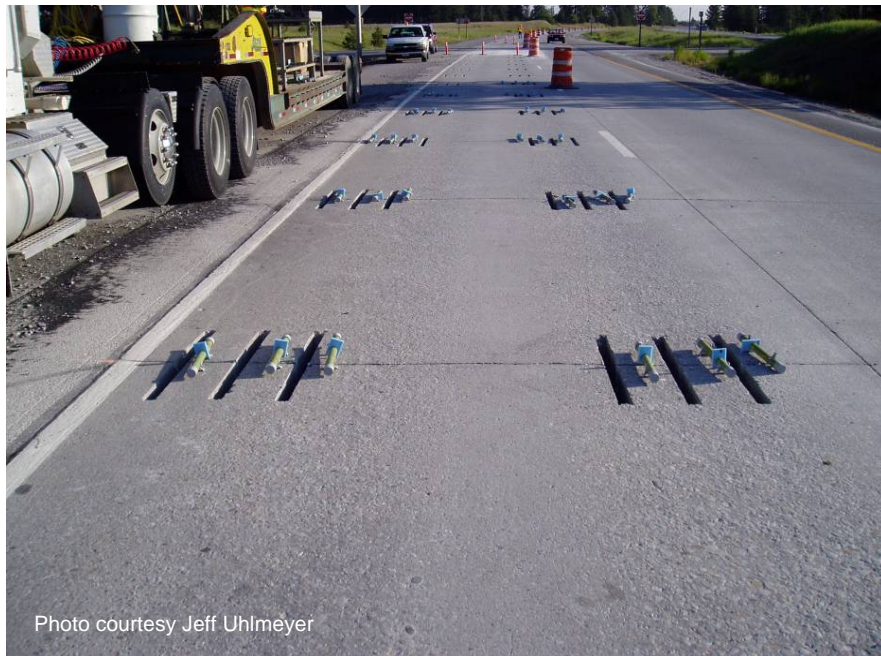
Figure 52 Dowel bar retrofit assemblies ready for installation.

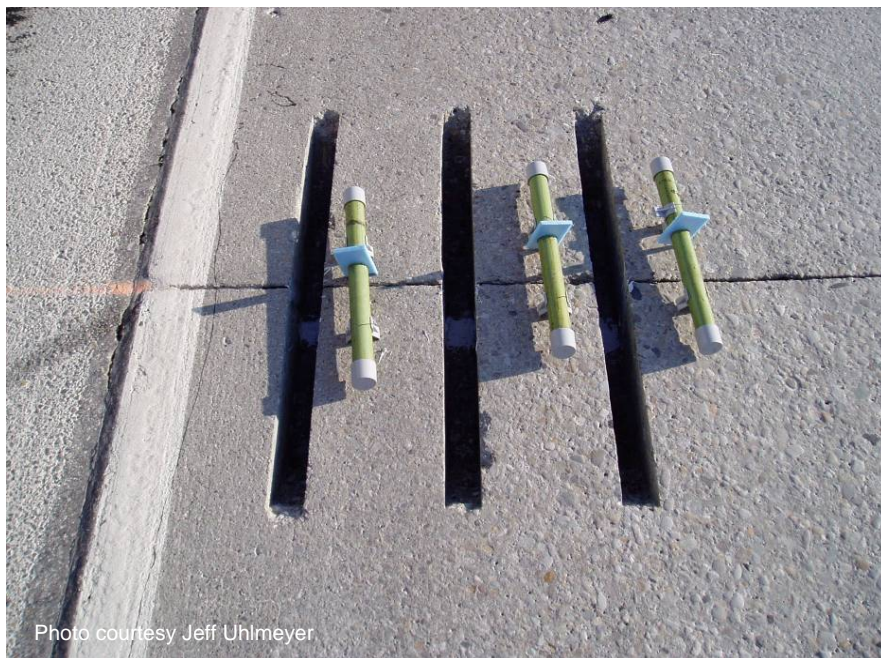
Figure 53 Close-up of dowel bar retrofit assemblies.

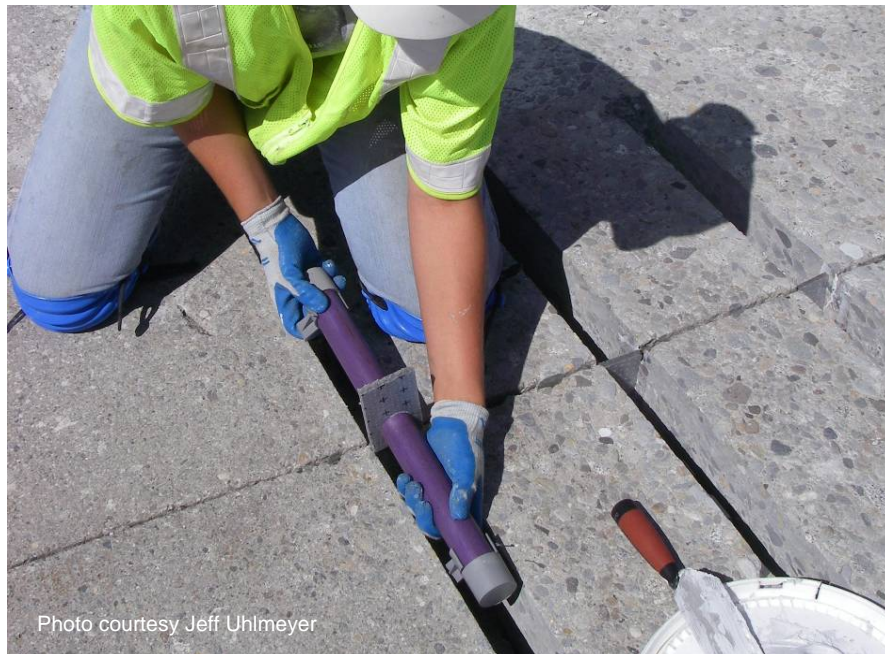
Figure 54 Inserting dowel bar retrofit assemblies into dowel bar slots.

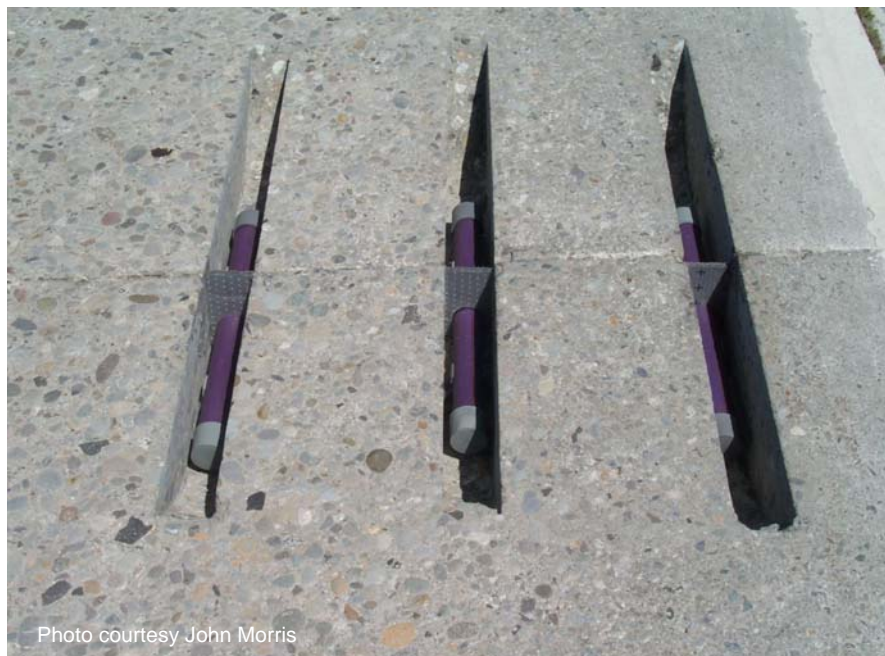
Figure 55 Dowel bar retrofit assembly at a transverse joint.

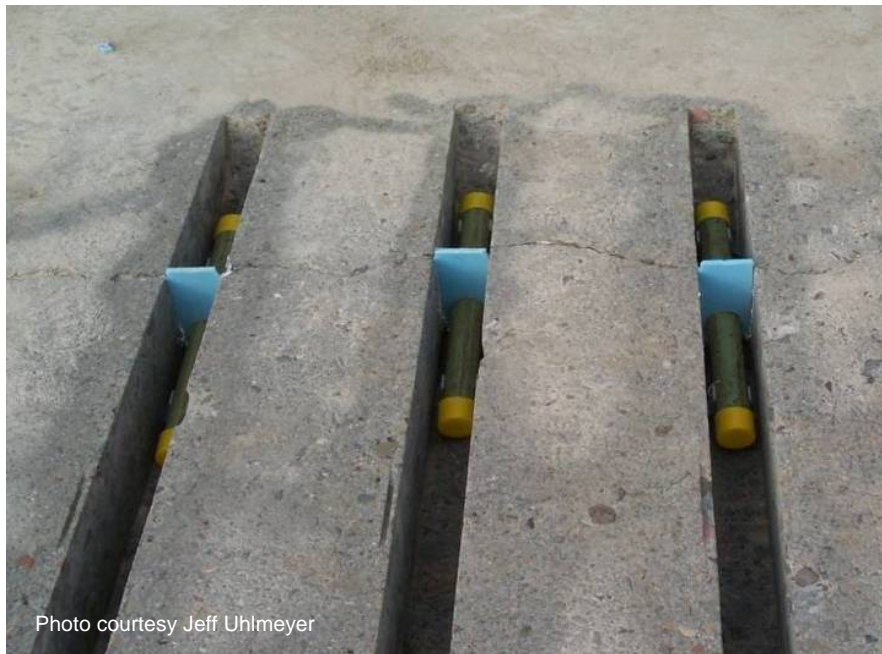
Figure 56 Dowel bar retrofit assembly at a transverse crack.

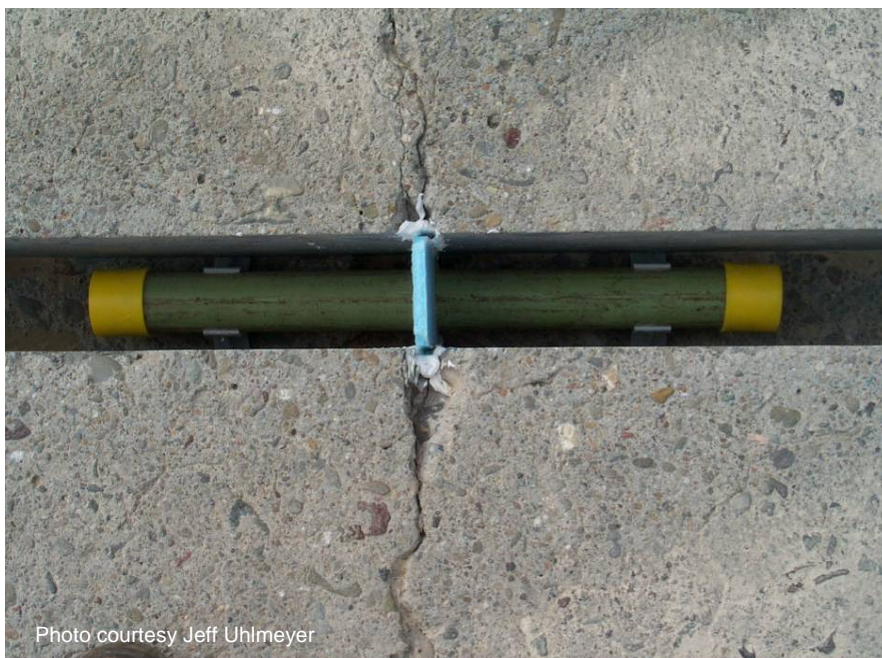
Figure 57 Close-up of dowel bar retrofit assembly at a transverse crack.

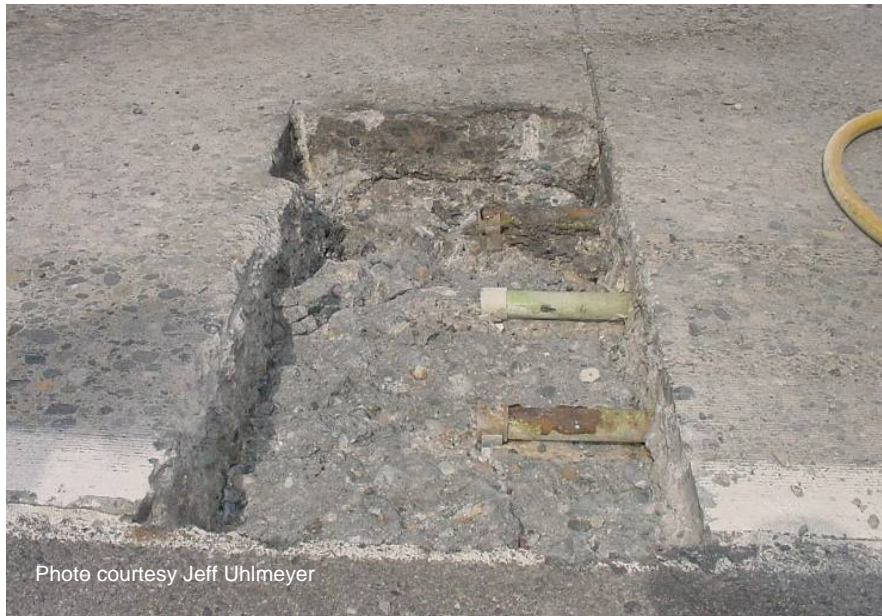
The dowel bar epoxy coating should be inspected and if any discrepancies are present the dowel bar should be rejected. On one particular project, dowel bar corrosion (Figure 58 and Figure 59) was determined to be the cause of the dowel bar slot failure.

Figure 58 Corroded epoxy coated dowel bars.

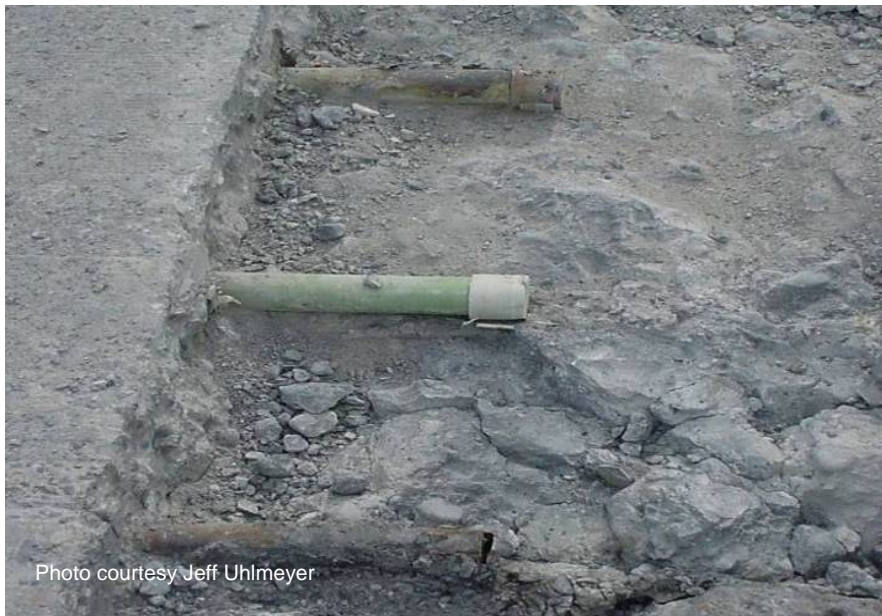
Figure 59 Close-up of corroded epoxy coated dowel bars.

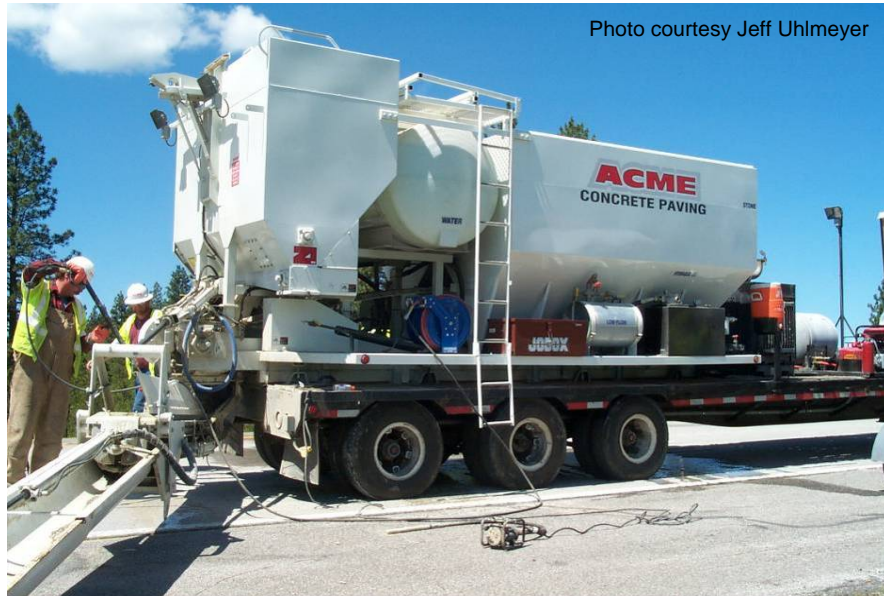
Patching material can be batched using a mobile mixer (Figure 60 and Figure 61) or in individual batches. If a mobile mixer is used, batching of the individual components must be closely monitored to ensure proper proportioning.

Figure 60 Mobile mixer.

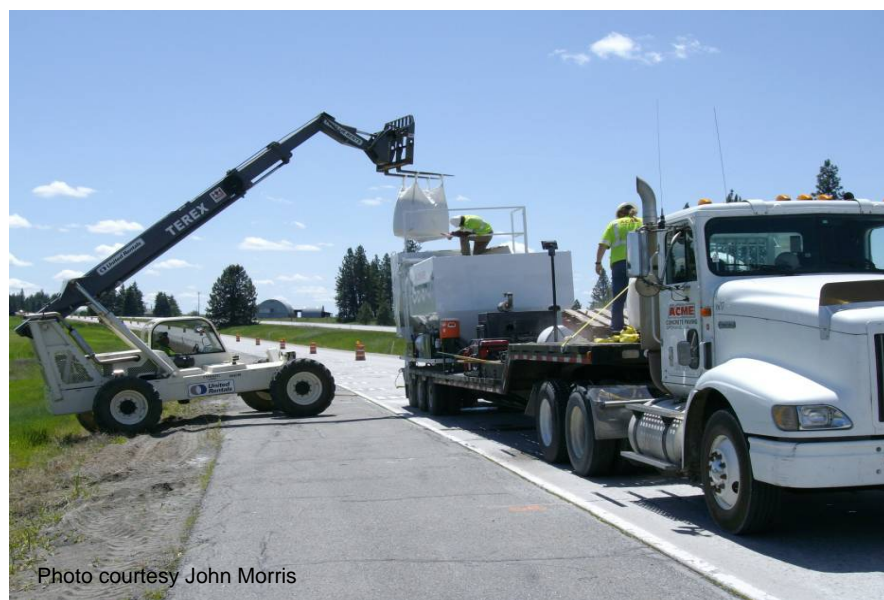
Figure 61 Delivery of materials to mobile mixer.

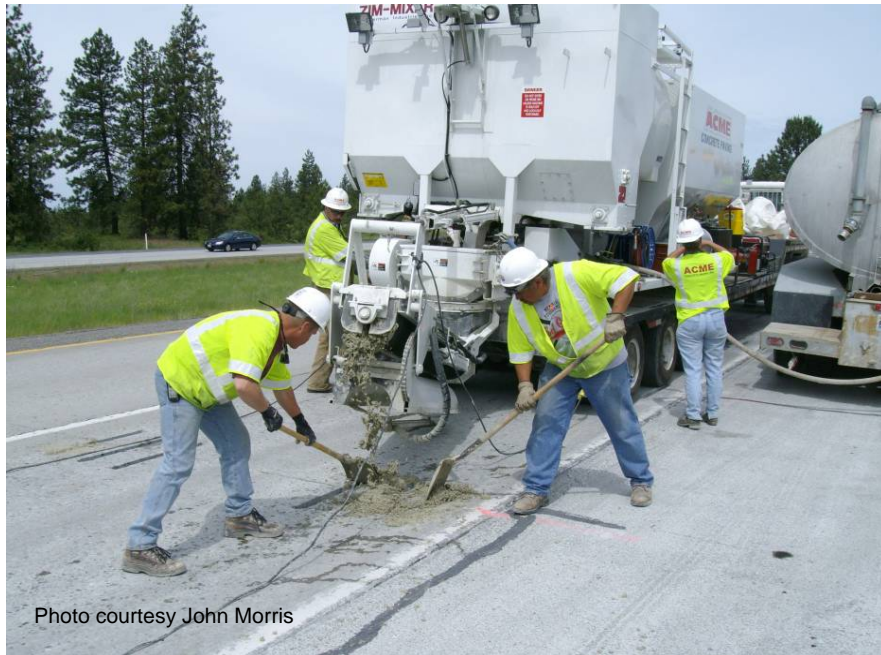
Patching material should not be dumped directly into the dowel bar slot; the impact of the patching material falling directly into the dowel bar slot will cause movement of the dowel bar retrofit assembly. The patching material should be placed adjacent (Figure 62 and Figure 63) to and spread with shovel (Figure 64) toward and into the dowel bar slot.

Figure 62 Placement of patching material.

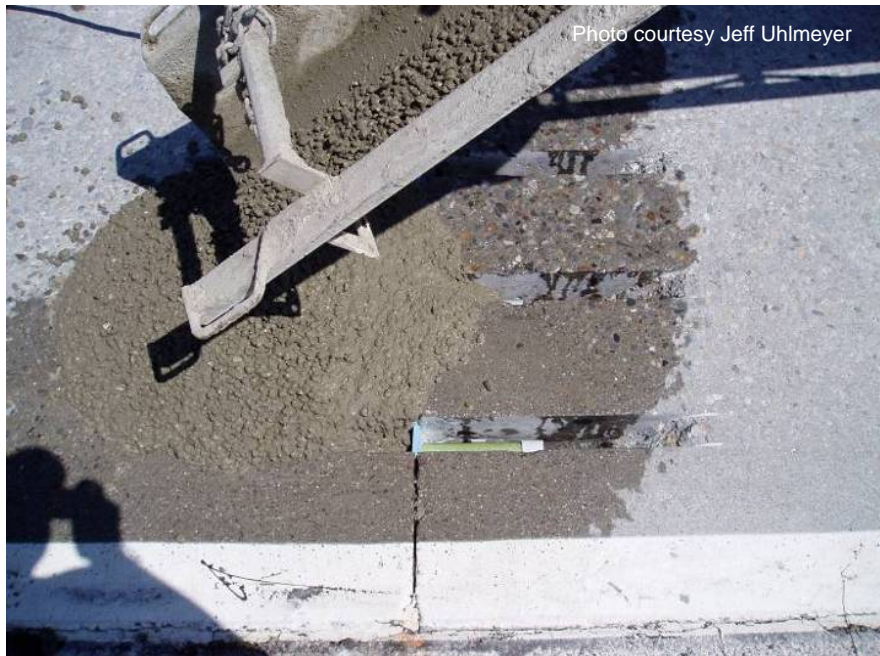
Figure 63 Placing patching material adjacent to dowel bar slots.

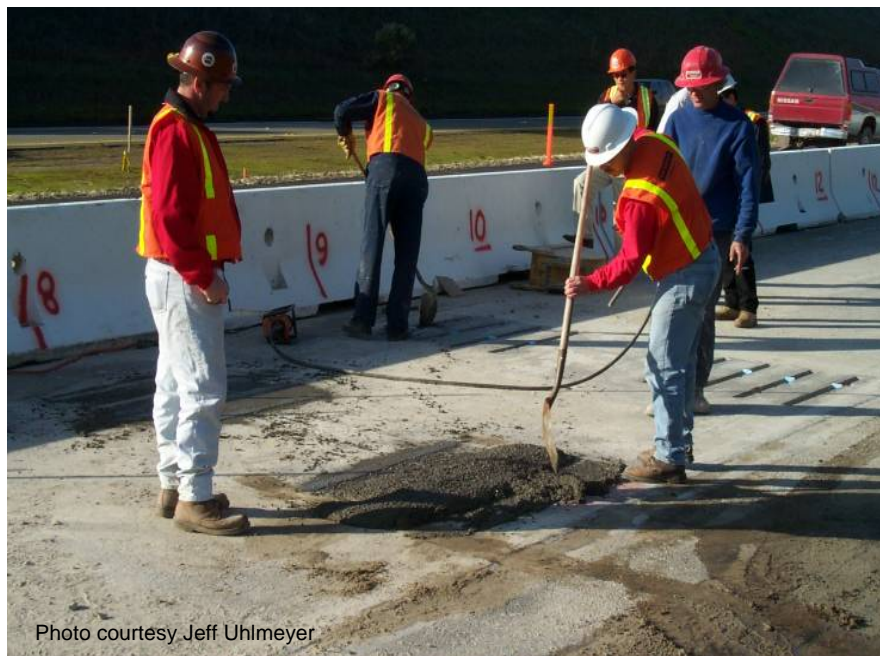
Figure 64 Moving patching material into dowel bar slots.

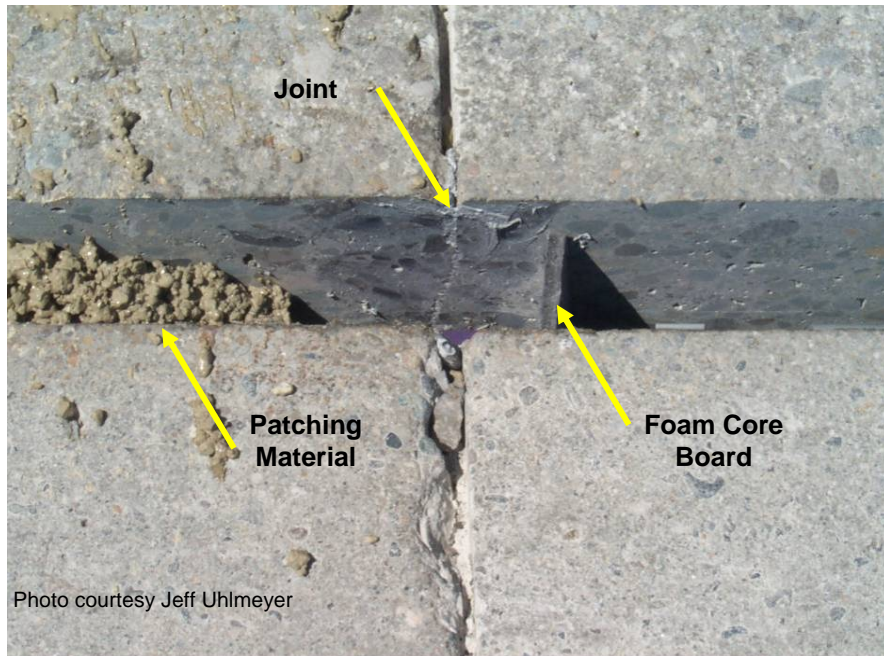
Placement of patching material that causes movement (Figure 65 and Figure 66) of the dowel bar retrofit assembly should be rejected and replaced.

Figure 65 Movement of bar during placement of patching material.

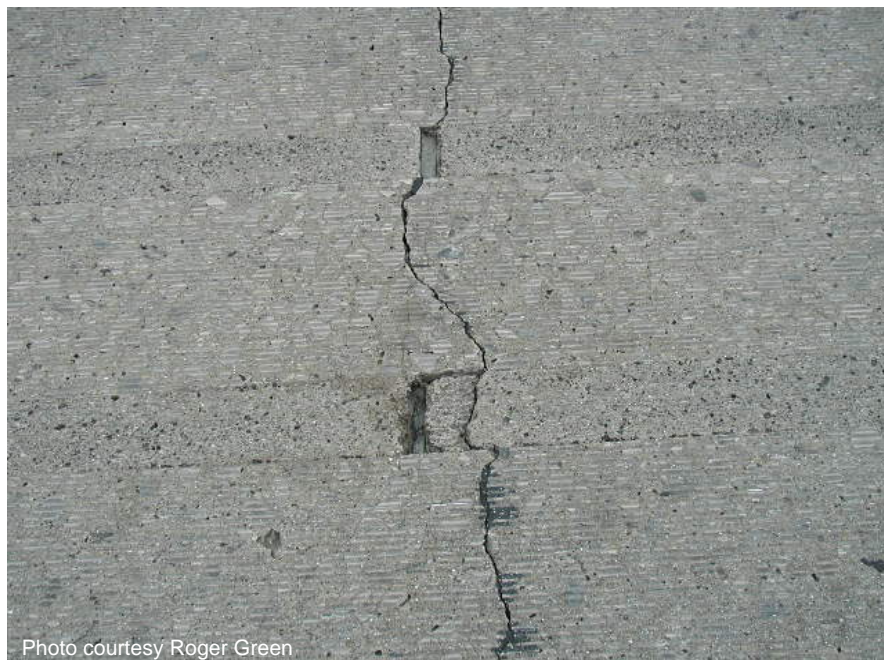
Figure 66 Misaligned foam core board.

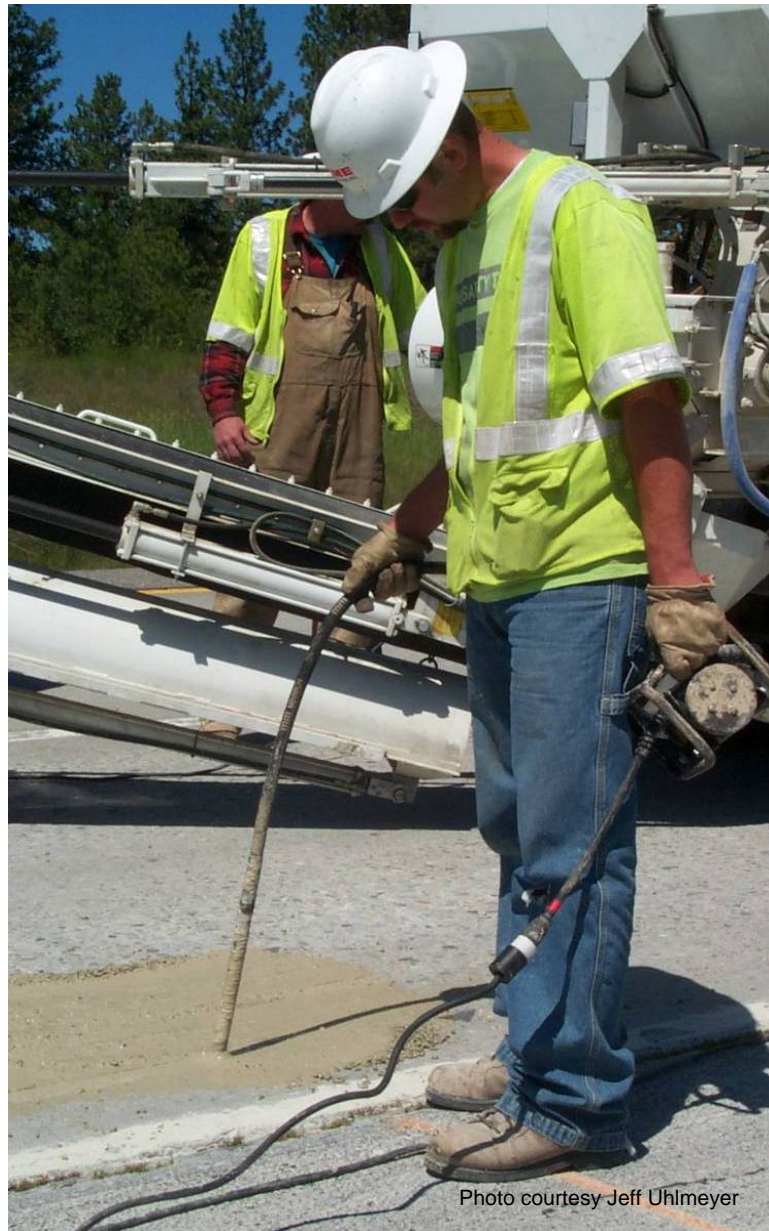
Patching material consolidation should be conducted with a pencil (or similar) vibrator (Figure 67). Care must be taken to not relocate the dowel bar retrofit assembly during consolidation.

Figure 67 Consolidating patching material.

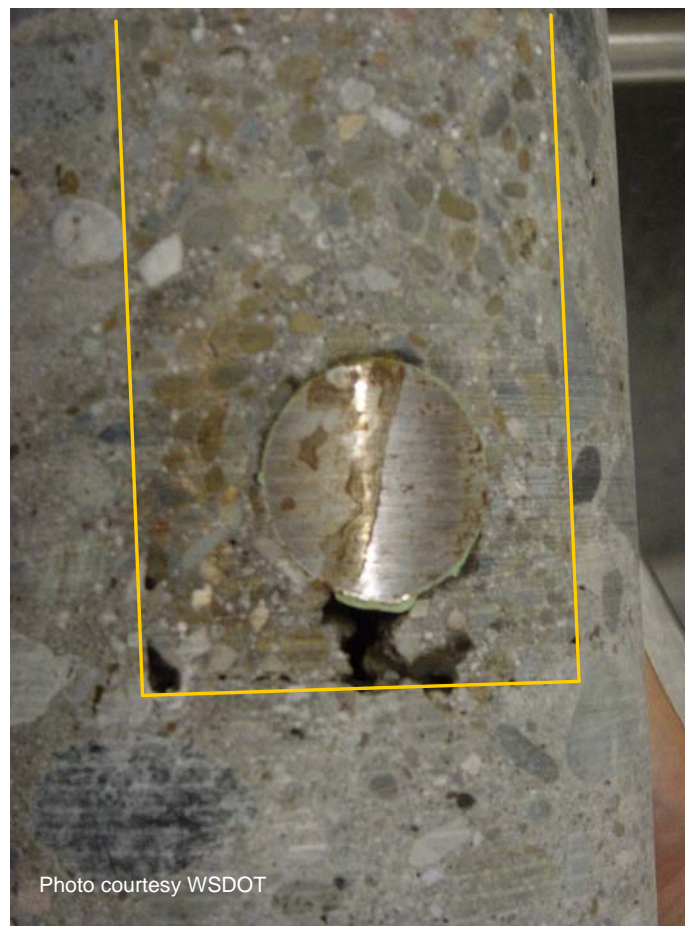
Figure 68 and Figure 69 illustrate patching material voids in the vicinity of the dowel bar. The core shown in Figure 68 was taken from the first dowel bar retrofit project and illustrates lack of consolidation beneath the dowel bar, which could be due to aggregate size and the inability to move the aggregate around the dowel bar or lack of consolidation. Figure 69, on the other hand, was taken from a more recent project (2006) and shows lack of consolidation around and above the bar. In this case, it was determined that the aggregate gradation was too large to adequately fit around the bar and WSDOT modified specifications to allow only AASHTO Grading No. 8 (prior to this project, either AASHTO Grading No. 7 or 8 was allowed).

Figure 68 Poor consolidation beneath bar.

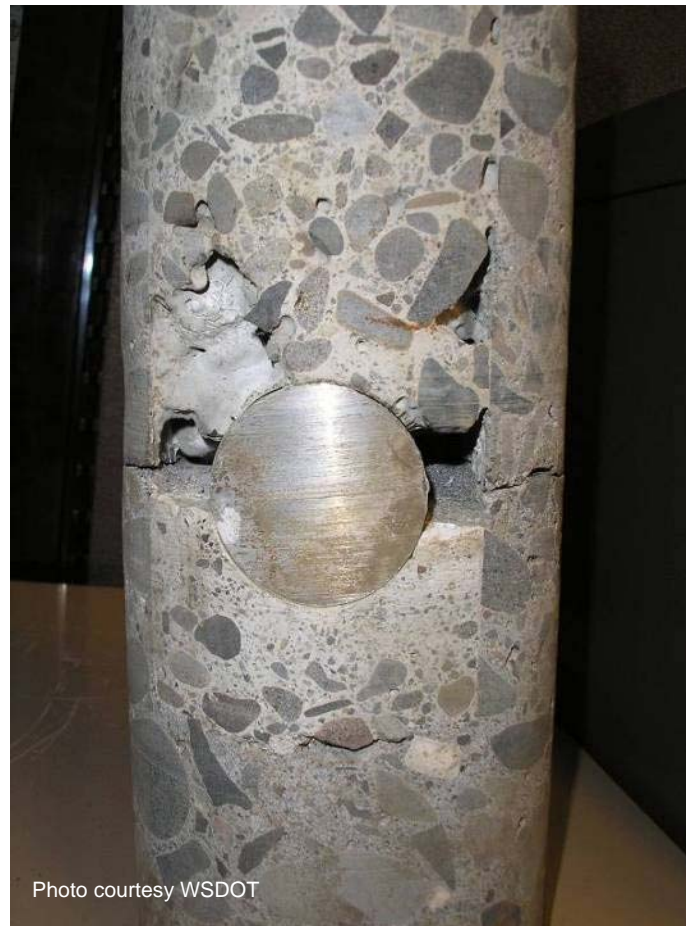
Figure 69 Poor consolidation around bar.

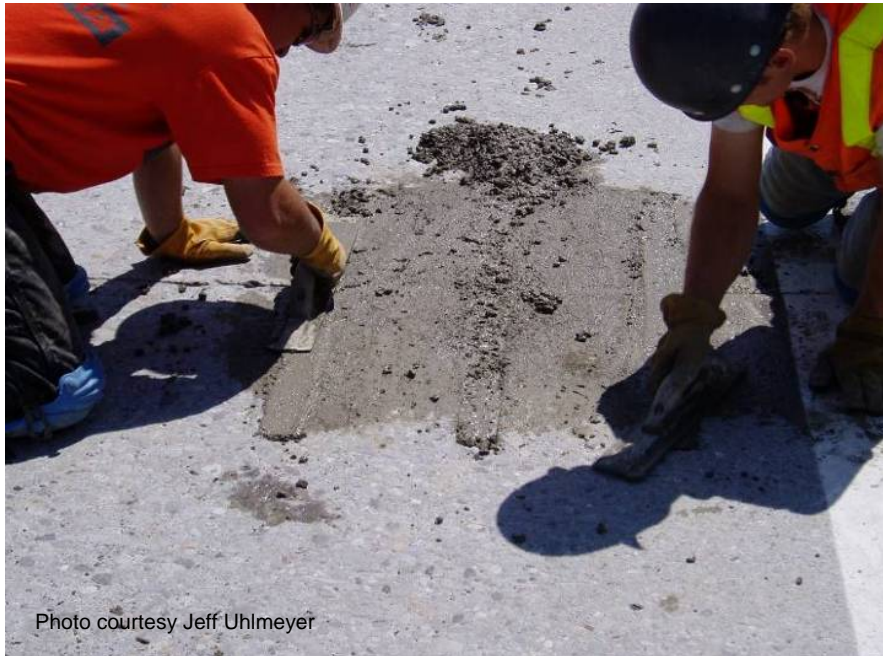
During the finishing process, care should be taken to not overwork the patching material (Figure 70 and Figure 71). Overworking can lead to segregation and floating of the fine material to the surface of the dowel bar slot. The fine material is susceptible to wear, especially when subjected to studded tires. Patching material should be left $\frac{1}{8}$ inch to $\frac{1}{4}$ inch high (Figure 72 and Figure 73), which will be removed during the diamond grinding process.

Figure 70 Finishing patching material.

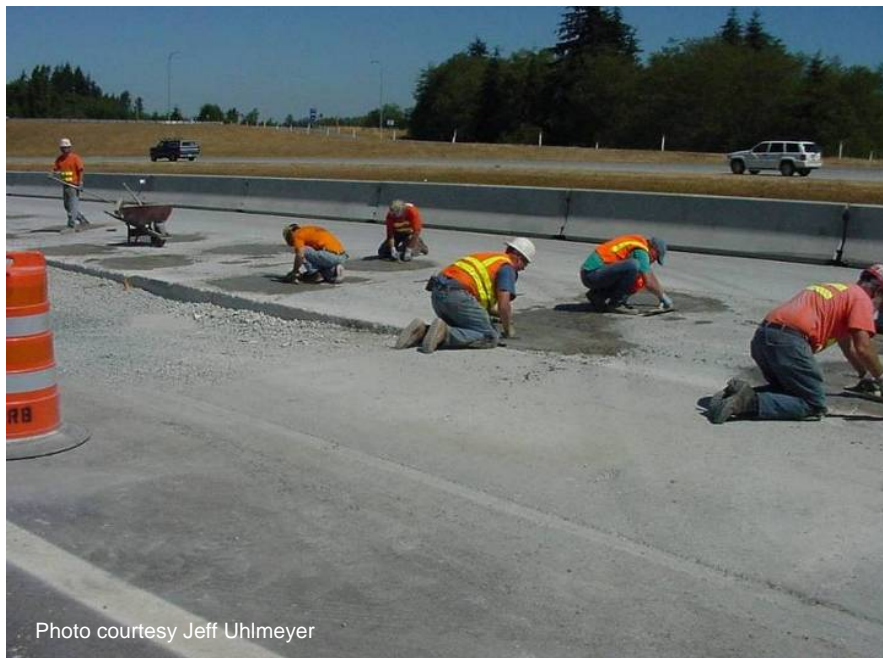
Figure 71 Finishing patching material.
