Dowel Bar Retrofit – Do's and Don'ts

WA-RD 576.2

March 2009

16. ABSTRACT This report documents construction and inspection guidelines for the successful construction of a dowel bar retrofit project.			
17. KEY WORDS Dowel bar retrofit, concrete rehabilitation, construction techniques		18. DISTRIBUTION STATEMENT No restrictions. This document is available to the public through the National Technical Information Service, Springfield, VA 22616

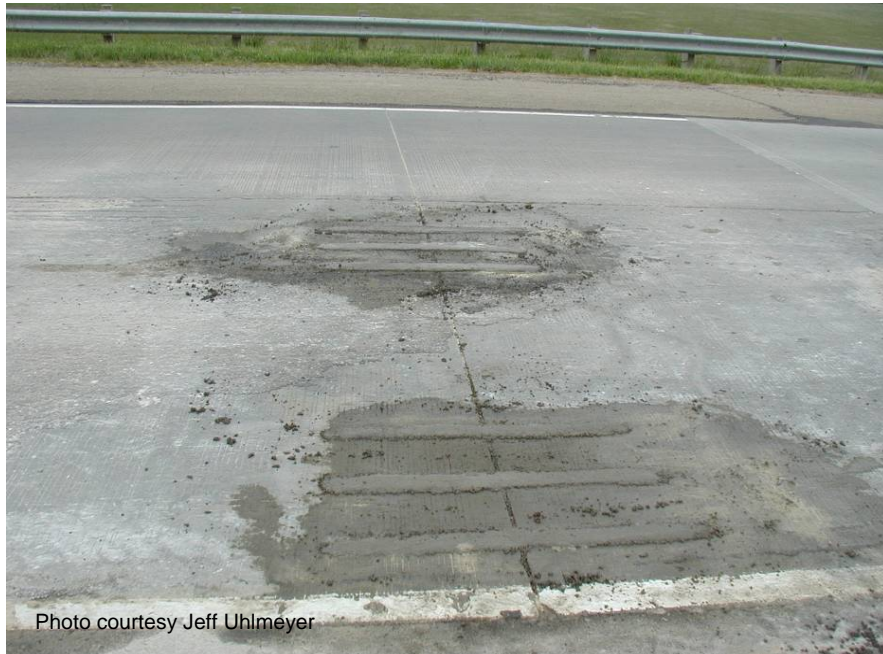
During the finishing process, care should be taken to not overwork the patching material (Figure 70 and Figure 71). Overworking can lead to segregation and floating of the fine material to the surface of the dowel bar slot. The fine material is susceptible to wear, especially when subjected to studded tires. Patching material should be left $\frac{1}{8}$ inch to $\frac{1}{4}$ inch high (Figure 72 and Figure 73), which will be removed during the diamond grinding process.

Figure 72 Patching material should be left high to prevent overworking

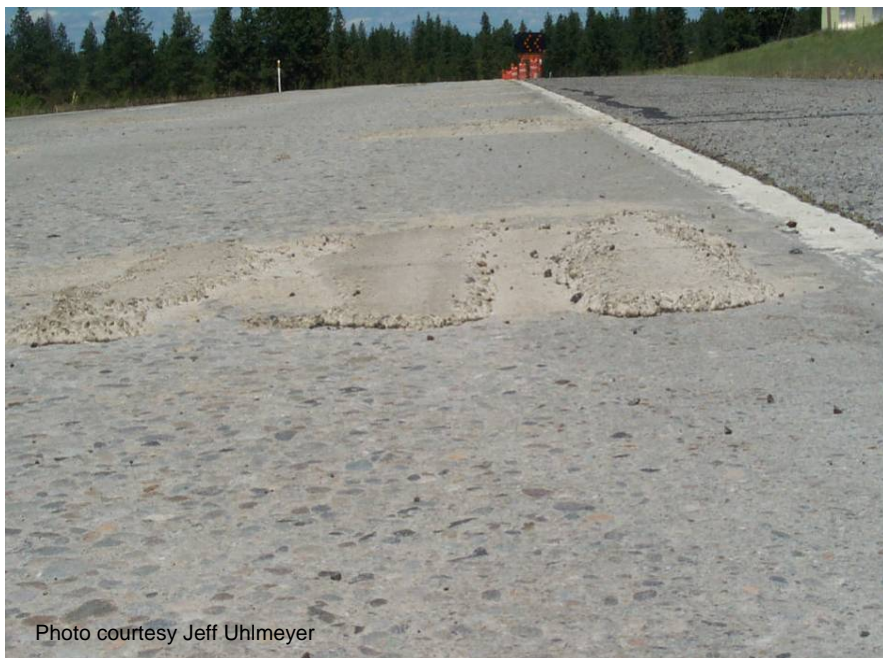
Figure 73 Patching material left high to minimize segregation.

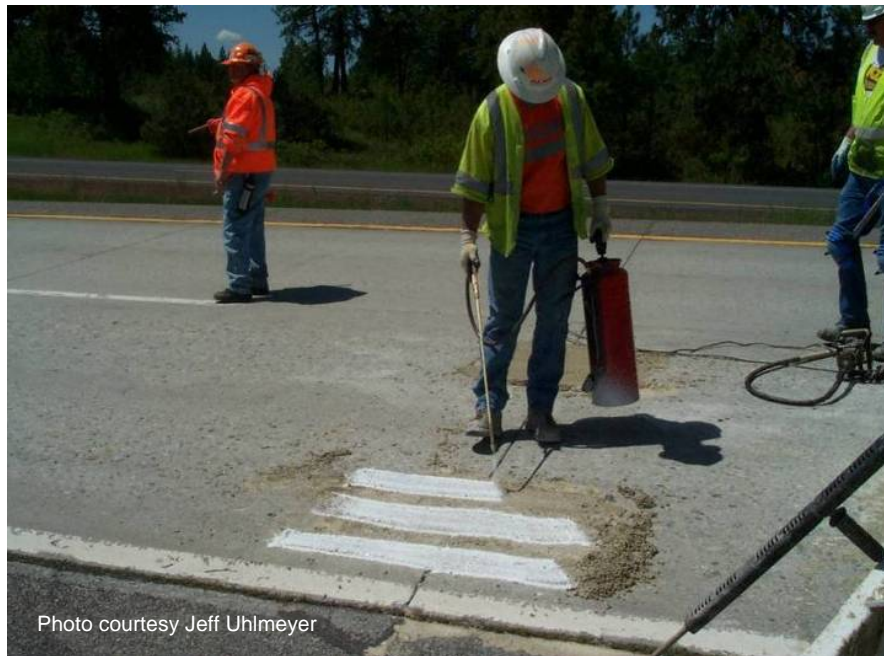
Curing compound should be applied (Figure 74) to the patching material as soon as possible after the finishing operation.

Figure 74 Applying curing compound.

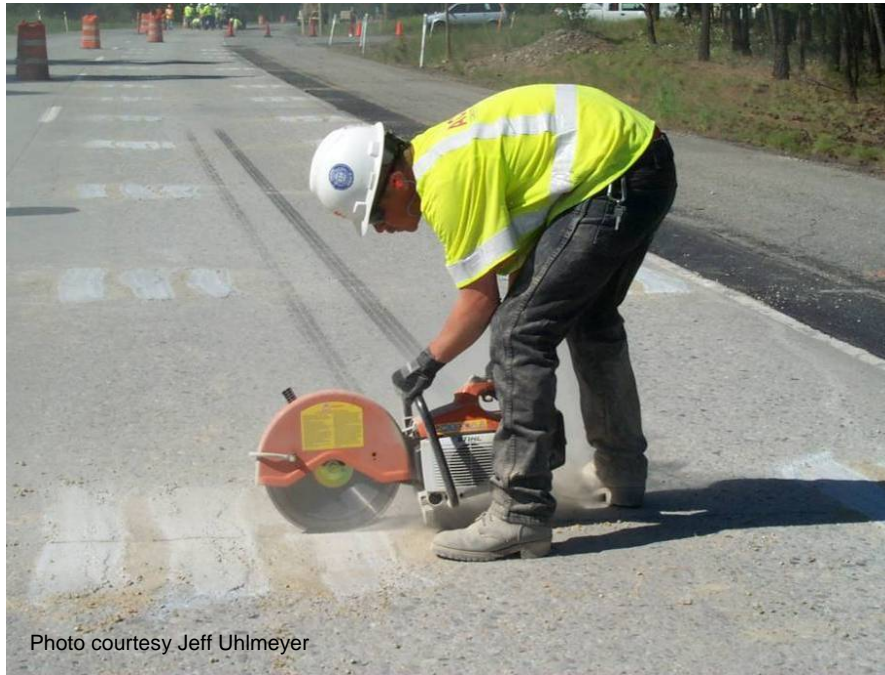
Establishing the transverse joint within the dowel bar slots (Figure 75) should be conducted within 24 hours after placement. If the transverse joints were originally constructed with a tape joint and the joint is uneven (Figure 76), the transverse joint should not be sawcut. In this situation, sawcutting a straight line would be challenging without creating slivers that would eventually spall.

Figure 75 Establishing joint in patching material.

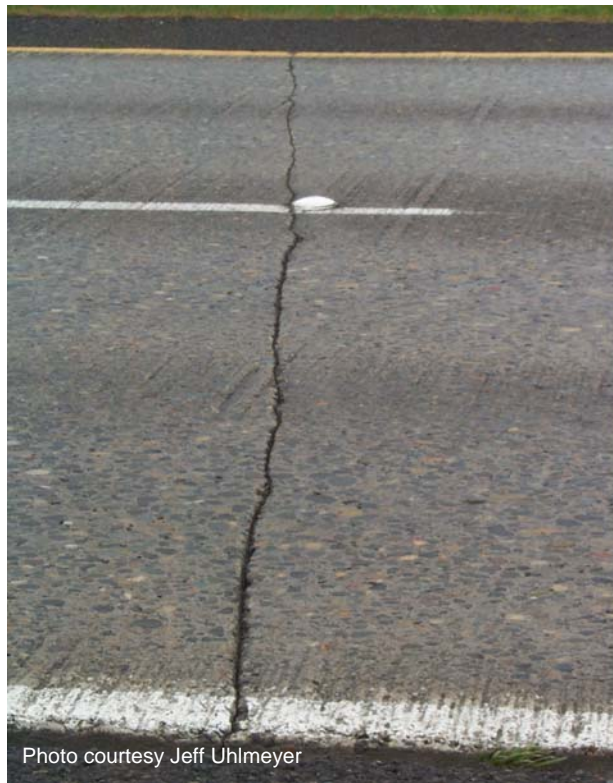
Figure 76 Transverse tape joint (original construction).

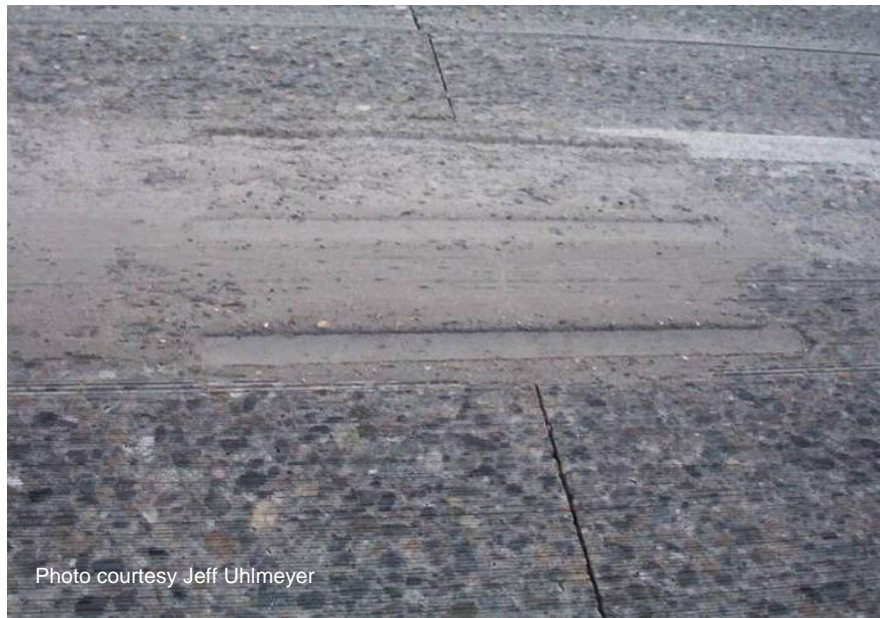
Figure 77 illustrates damage caused by mechanically sweeping the roadway prior to the patching material reaching the required strength. As before, the methodology for repairing this distress is to saw cut, remove and replace two to three inches of the distressed material.

Figure 77 Mechanical sweeping prior to patching material reaching strength.

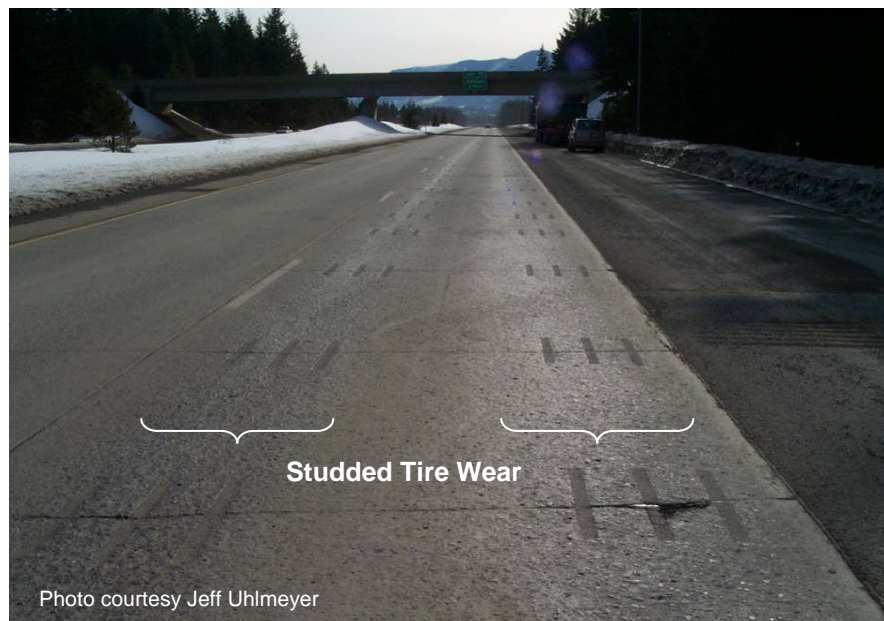
Studded tire wear is one of the more predominant distresses affecting pavement (both HMA and concrete) performance in Washington State. For dowel bar retrofit, the largest impact of studded tires is wear in the dowel bar slot (Figure 78 and Figure 79).

Figure 78 Wear due to studded tires.

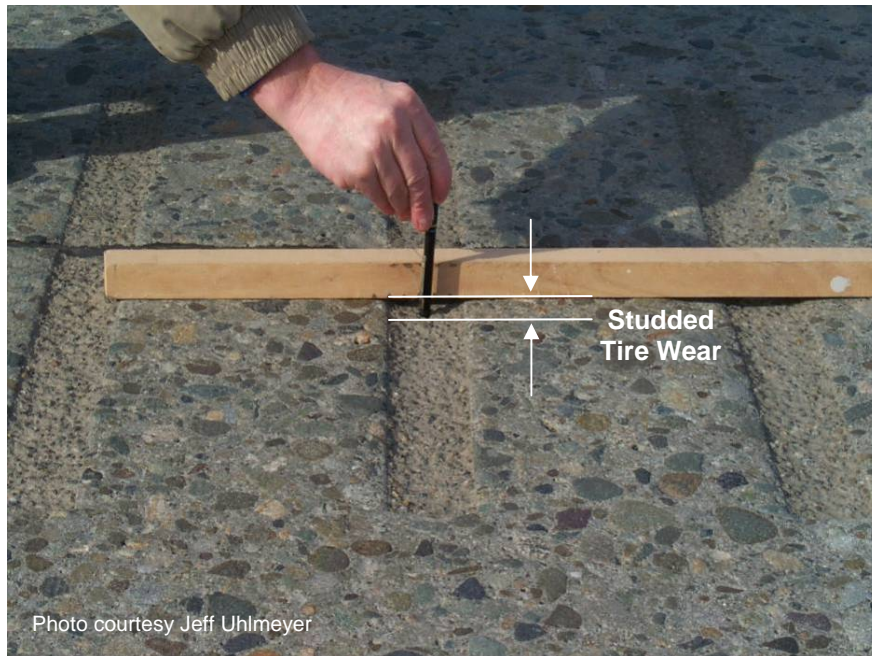
Figure 79 Wear due to studded tires.

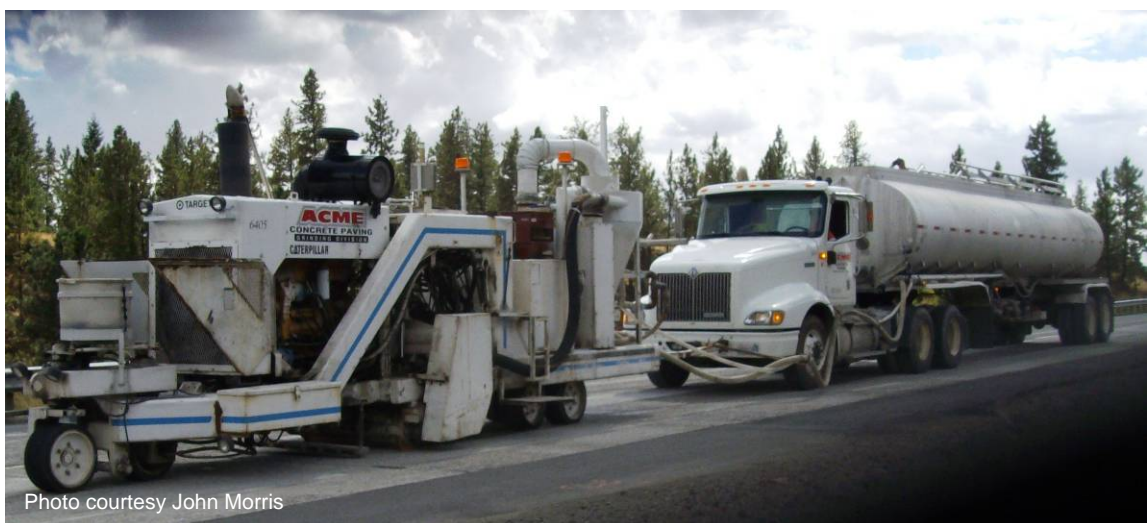
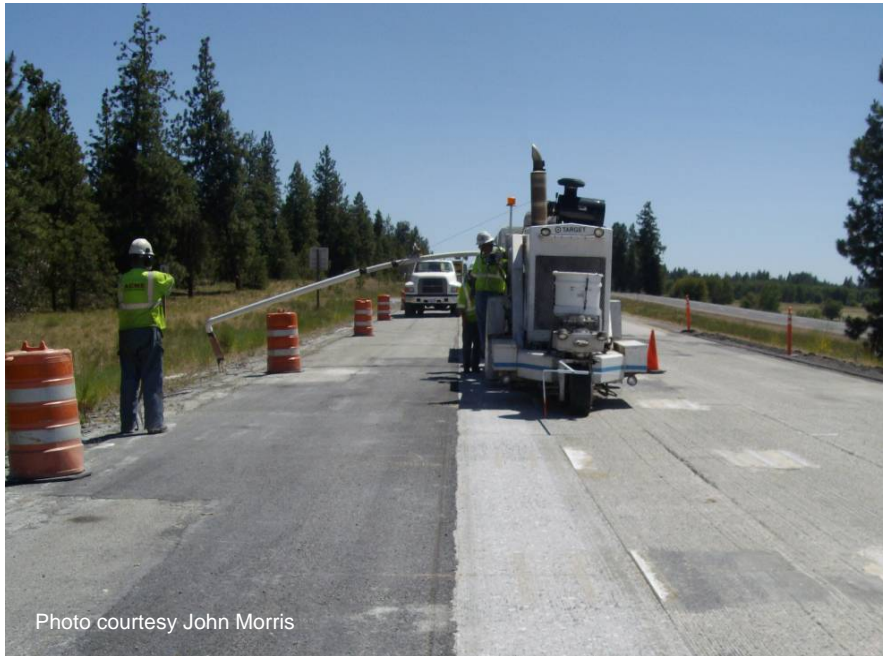
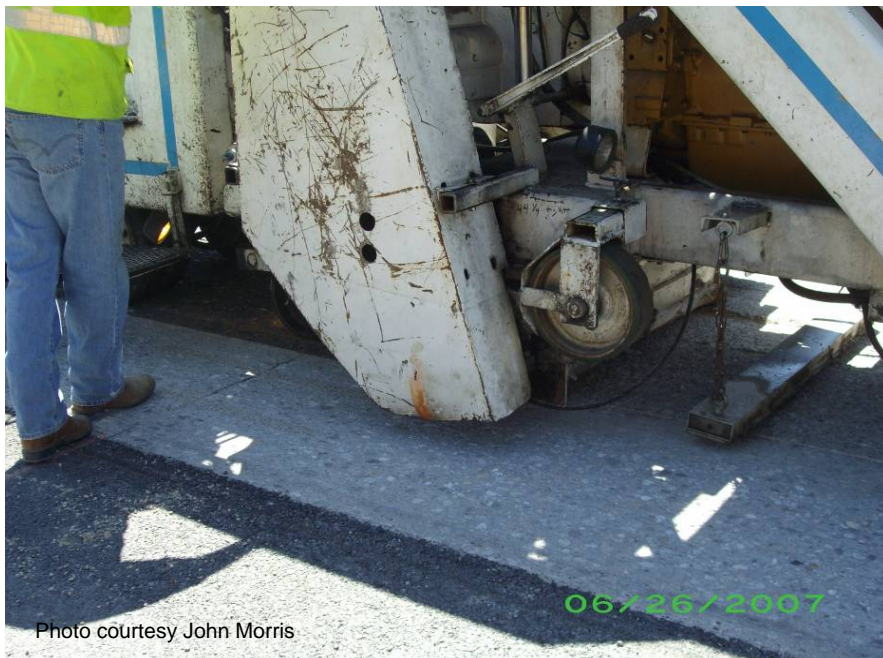
Diamond grinding (Figure 80 through Figure 82) should begin within 10 working days of placing dowel bar retrofit patching materials. The primary reason for this specification is to minimize traveler complaints related to intentionally leaving dowel bar patching material high.

Figure 80 Diamond grinding equipment.

Figure 81 Diamond grinding equipment.

Figure 82 Diamond grinding equipment.

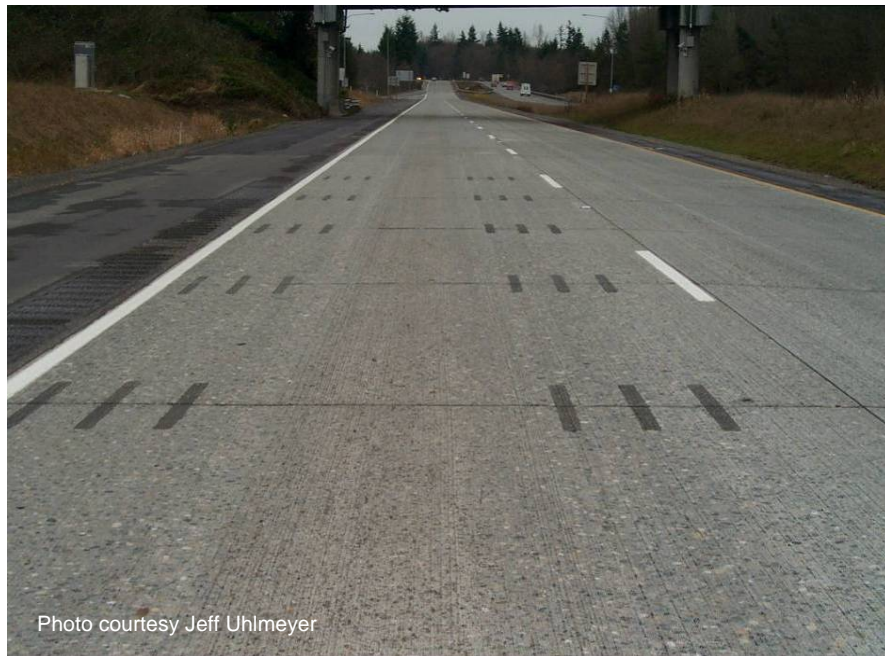
Figure 83 and Figure 84 illustrate successful completion of the dowel bar retrofit process.

Figure 83 Completed roadway.
