GUIDE TO THE PREVENTION AND RESTORATION OF EARLY JOINT DETERIORATION IN CONCRETE PAVEMENTS

DECEMBER 2016

National Concrete Pavement
Technology Center

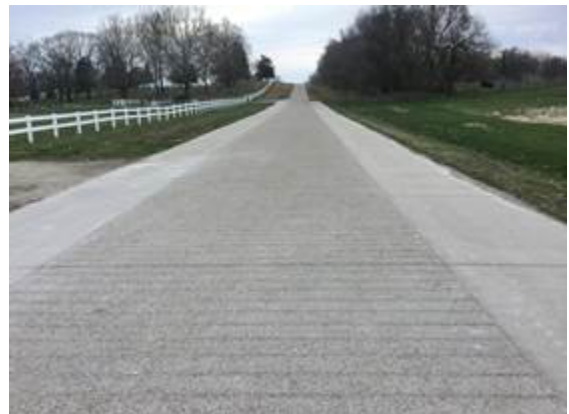
Figure 1-1. Eddyville, Iowa, cemetery road in spring 2016 (photo courtesy of Kevin Merryman, Iowa DOT)

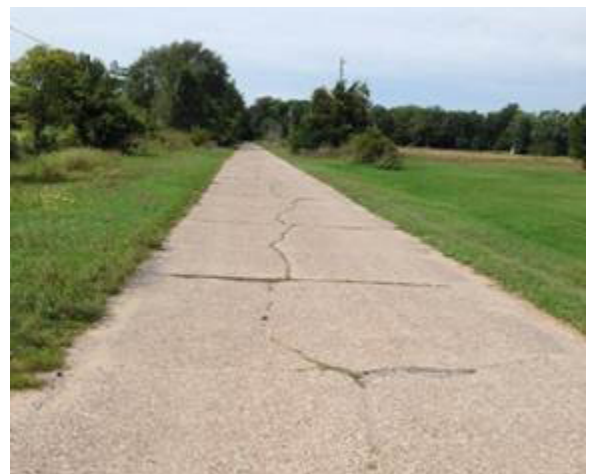
Figure 1-2. Moscow street in 2014 (photo courtesy of Kurt Smith, Applied Pavement Technology, Inc.)

Since Iowa's first portland cement concrete pavement was constructed in Le Mars in 1904 (Hanson 2009), engineers have observed joints from a design as well as a performance standpoint. Many concrete pavements built in Iowa with durable materials and good construction techniques have performed well beyond their estimated design lives. Two examples are the Eddyville cemetery road placed in 1909 and still in service today (Figure 1-1) and a 16-foot (ft) wide pavement with 25-ft transverse joints in Moscow, Iowa, which was placed in 1914 and is in service today as a residential street (Figure 1-2).

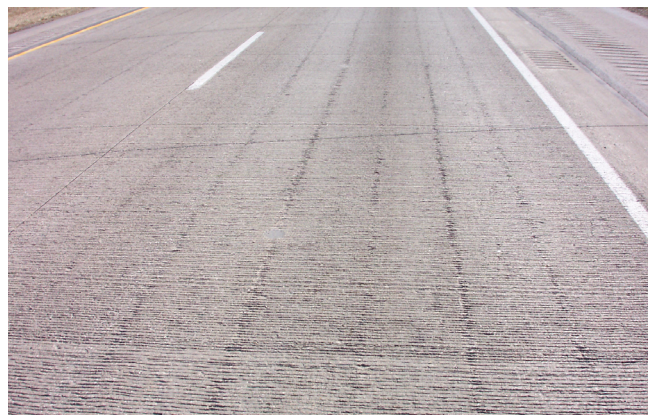
Figure 1-3. Vibrator trails

In 1991 a section of U.S. 20 in Hamilton and Webster counties, which was placed in 1987, began to show visible deterioration at the joints and along vibrator trails (Figure 1-3). Similar deterioration began to appear on several other paving projects placed between 1986 and 1994. Several research projects identified the cause as a loss of air at the joints and in the vibrator trails, increasing the pavements' exposure

to freeze-thaw damage. Solutions were also identified to avoid similar problems in new pavements: require vibration monitoring equipment to ensure proper vibration speed and control, improve workability through optimized aggregate gradations, and increase the use of slag cement in the mixture.

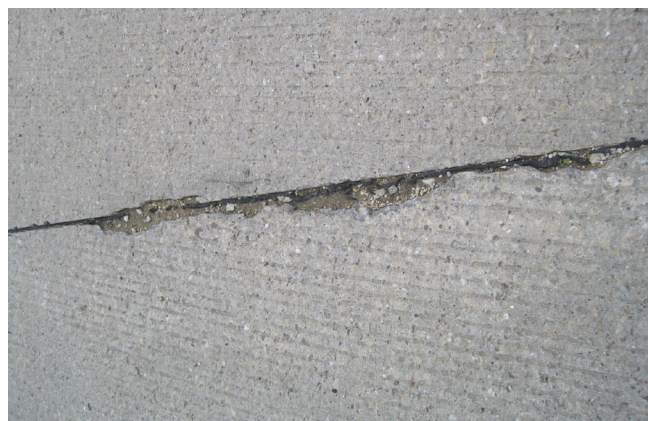
Figure 1-4. Joint deterioration (Photo courtesy of Jim Grove, FHWA)

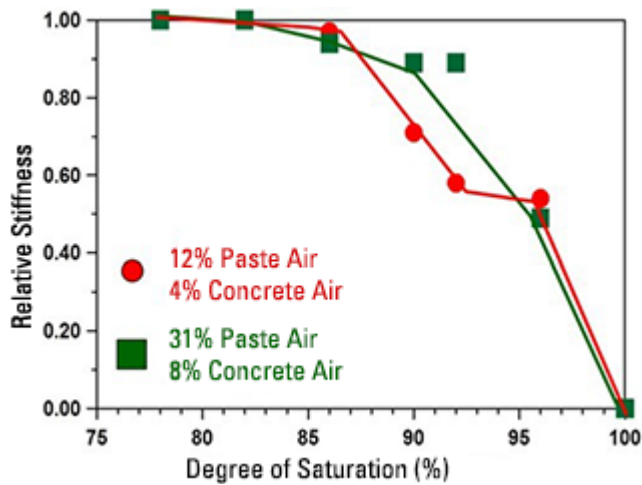
Figure 2-1. Influence of the DOS on stiffness degradation due to freeze-thaw damage (Li et al. 2011)

For degrees of saturation below the critical DOS (e.g., 85 percent in Figure 2-1), freeze-thaw damage is generally not observed to occur even after a large number of freeze-thaw cycles. As soon as the DOS exceeds the critical DOS (in this case 85 percent), damage initiates in the material, regardless of the quantity and quality of the air system. This implies that once the critical DOS is reached, even a single freezing

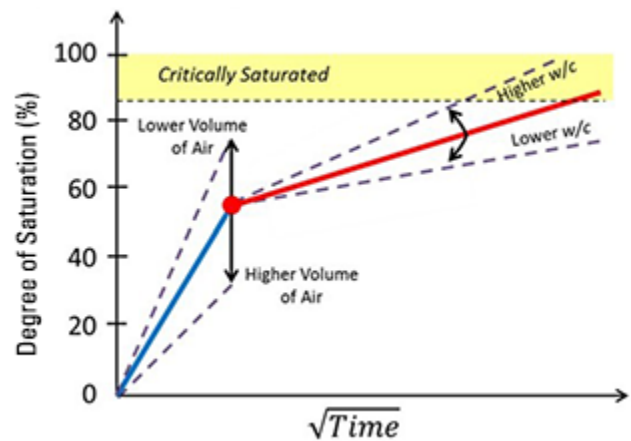
Figure 2-2. A conceptual illustration of the sorption-based freeze-thaw model

Entrained air can improve freeze-thaw durability by reducing the DOS in concrete (Li et al. 2011, 2016). Air-entraining admixtures stabilize air bubbles generated during mixing to add large (approximately 0.002 to 0.050 in.), stable, air-filled voids to the paste portion of the concrete (Mindess and Young 1981). These entrained air voids provide air-filled voids that reduce the initial DOS, as shown in Figure 2-3 (i.e., the initial saturation is the saturation that occurs during the first 24 hours, as denoted by the nick point or transition from the

blue to the red line in Figure 2-2). Figure 2-3(a) shows that both air content and water-to-cement (w/c) ratio contribute to the initial DOS when the same amount of cement is used in a mixture. As the w/c ratio increases and air content decreases, the concrete is closer to critical saturation after only a short time of exposure to water. The mixture composition can also impact the slope of the secondary absorption (red line in Figure 2-2), with data shown in Figure 2-3(b) for a straight cement mixture. Preliminary data have shown that this can

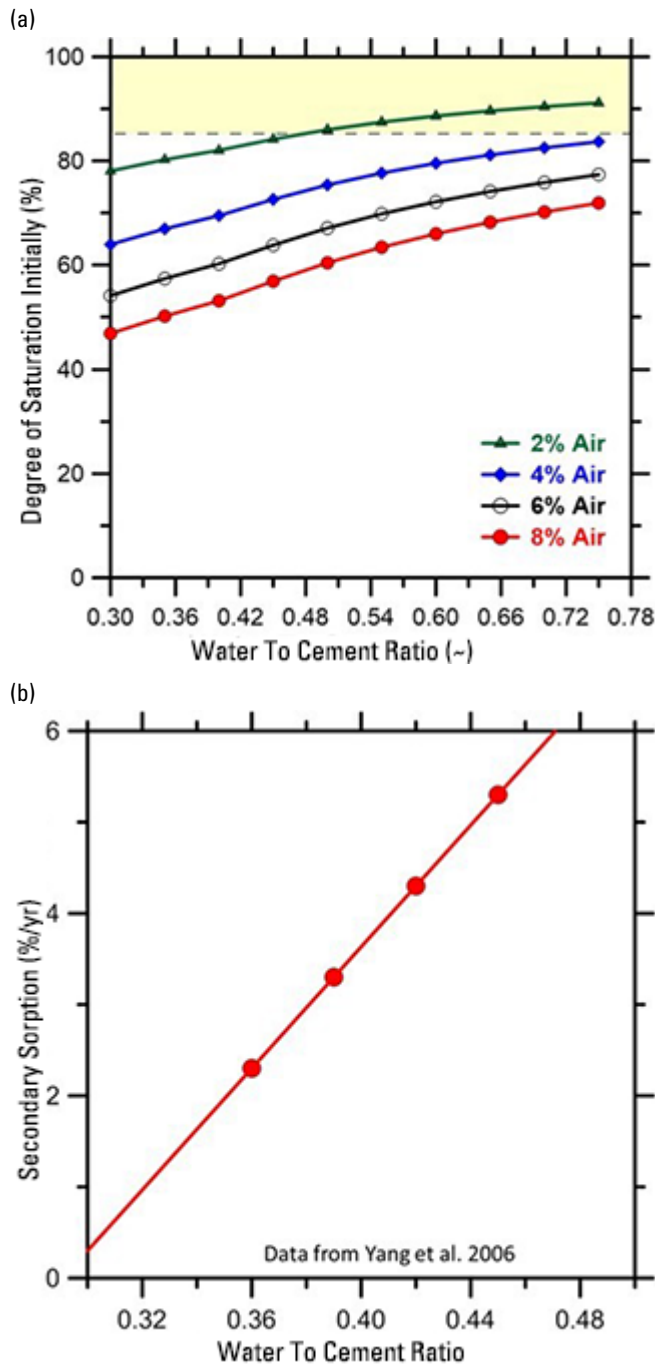
Figure 2-3. Influence of (a) the w/c ratio and air content on SMatrix and (b) the w/c ratio on the secondary sorption (Todak et al. 2015b)

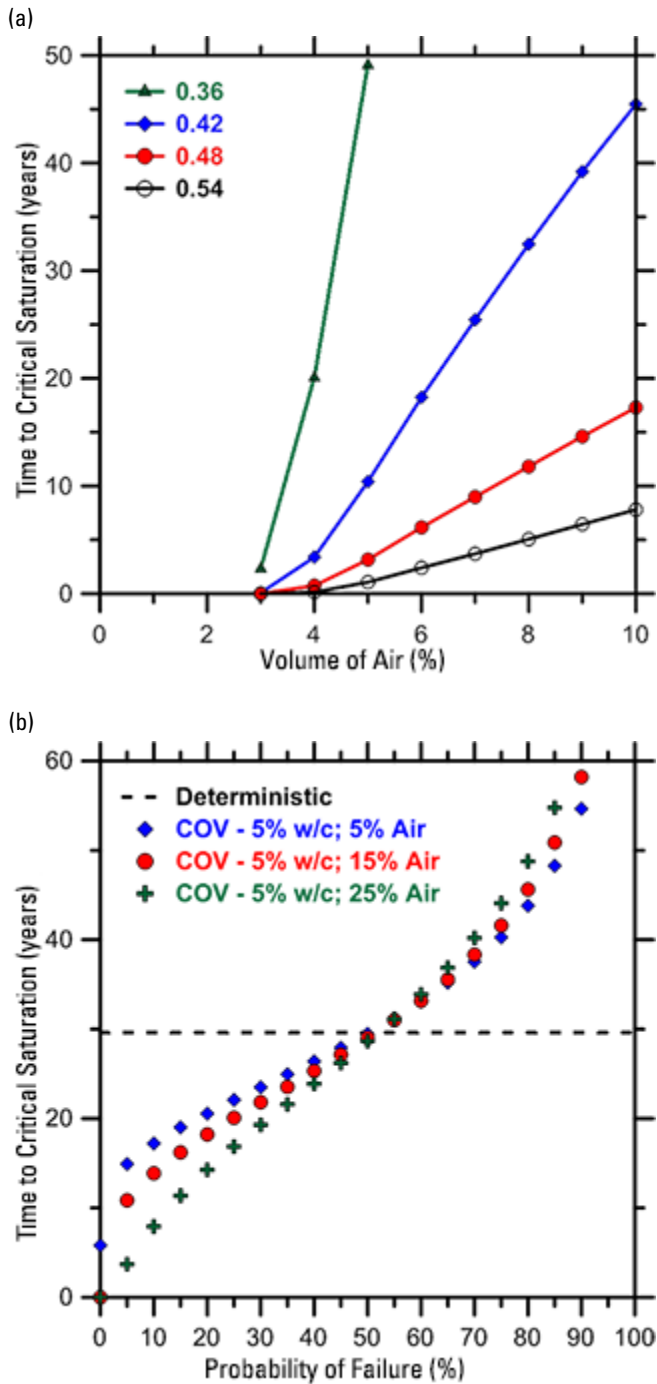
Figure 2-4. The influence of w/c ratio and air volume on the time required for 20 percent of the concrete to reach critical saturation (assuming 5 percent COV in w/c ratio and 15 percent COV in air content)

Variability in the concrete mixture can impact the life-cycle performance of the concrete. The Monte Carlo simulation model was used to indicate the influence of variation in w/c ratio (fixed at 5 percent coefficient of variation, COV) and variation in air content (5 percent, 15 percent, and 25 percent COV). The variation in the air content corresponds to 95 percent of the data ranging between 5.4 percent and 6.6 percent for the case with 5 percent COV, 4.2 to 7.8 percent for 15 percent COV, and 3.0 to 9.0 percent for the 25 percent COV. It can be noted from Figure 2-4(b) that the deterministic prediction of the time to saturation is similar to the time predicted for 50 percent of the elements to fail. It is interesting to note, however, that higher variability in air content (5 to 15 to 25 percent COV) results in time of failure of 17.2, 13.8, and 7.9 years, respectively. This would imply that despite the average air content, which is the same for each of these cases, repairs would need to be performed at an earlier age for systems with a higher variability. This clearly indicates the importance of controlling the variation in the air content during production. This needs to be balanced, however, with an understanding of how accurately the air content can be measured (Pellinen et al. 2005).

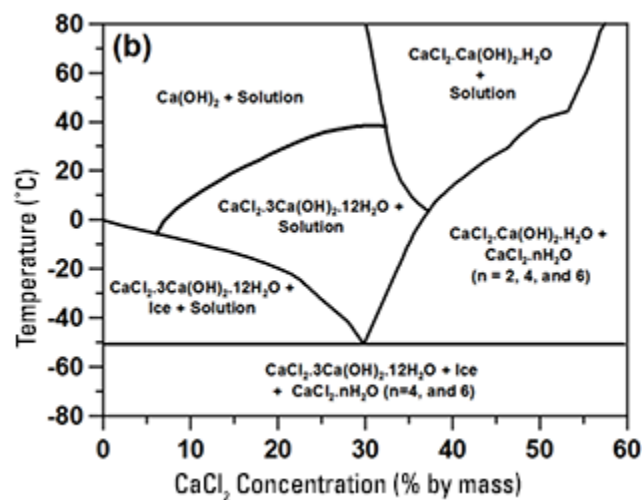
Figure 2-5. Phase diagrams illustrating the temperature for calcium oxychloride formation when hydrated cement paste is brought into contact with calcium chloride solution (Farnam et al. 2016)

The second type of reaction that may be observed, and that can cause more damage to concrete, occurs between calcium chloride and calcium hydroxide ($\text{Ca}[\text{OH}]_2$) (CH in cement chemistry shorthand) to result in calcium oxychloride ($\text{CaCl}_2 \cdot 3\text{Ca}[\text{OH}]_2 \cdot 12\text{H}_2\text{O}$), as shown in Equation 4. Calcium oxychloride is expansive and can result in damage to the cement matrix. Greater amounts of calcium oxychloride form at higher concentrations (Farnam et al. 2014; Farnam et al. 2015a) and at temperatures greater than freezing, as shown in Figure 2-5 (Farnam et al. 2016).

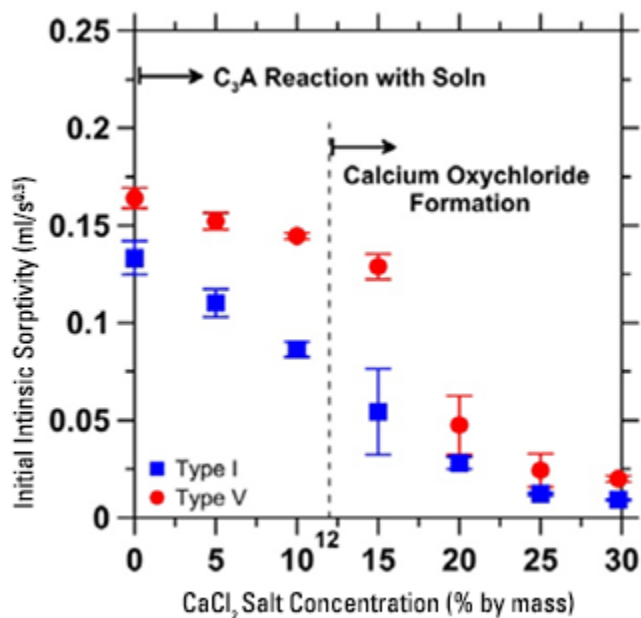
Figure 2-6. Reduction in the rate of water absorption due to salt reactions

Damage associated with salt-matrix reactions consists of the loss of concrete "flakes" ranging from 0.125 to 0.25 in. from around the joint. This damage tends to dislodge aggregate, because calcium oxychloride preferentially occurs around the aggregate because $\text{Ca}(\text{OH})_2$ (or CH) tends to deposit at the surface of the aggregate during hydration.

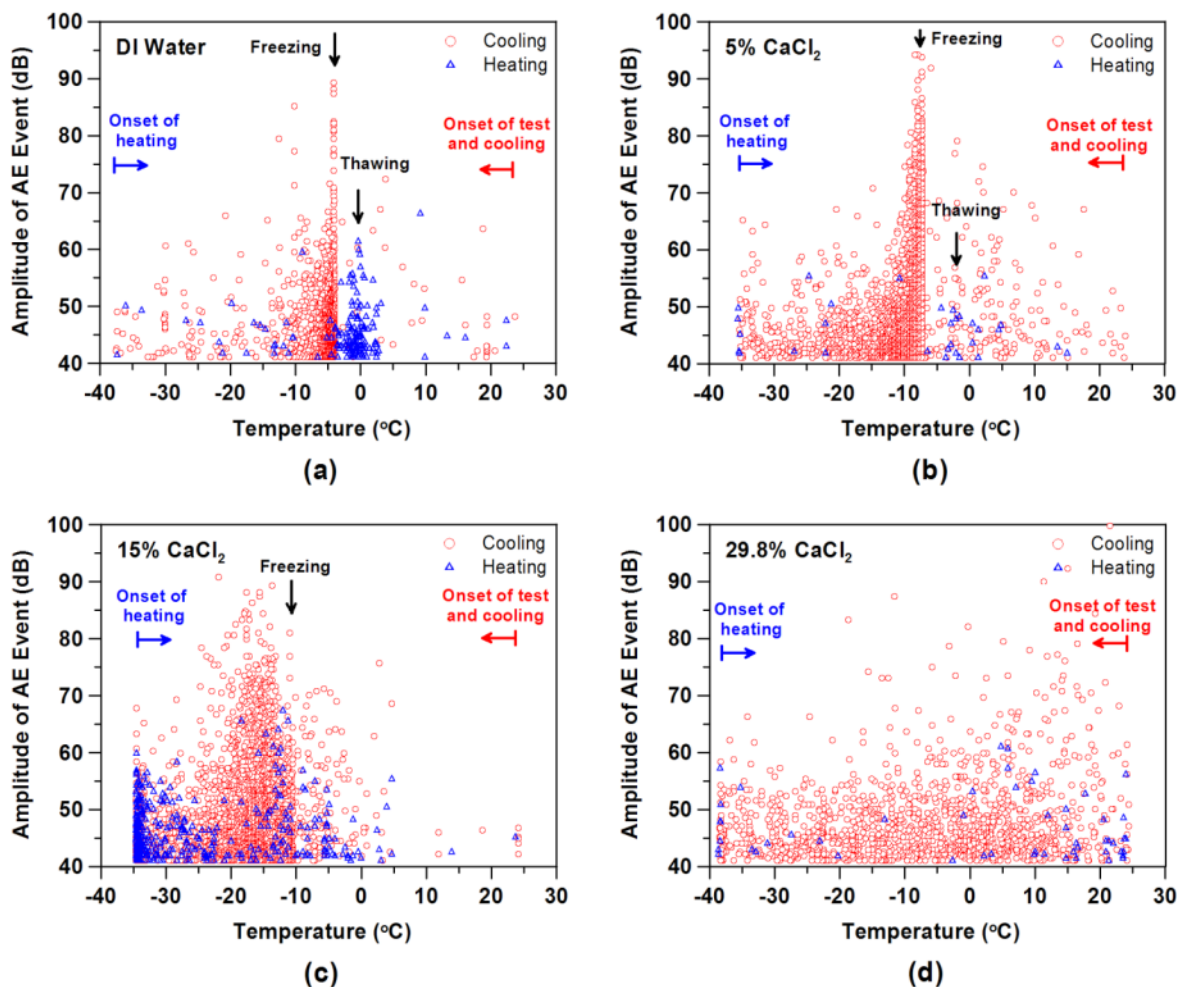
Figure 2-7. Passive AE events versus temperature during cooling and heating for mortar specimens saturated with (a) deionized water; (b) 5 percent CaCl_2 solution; (c) 15 percent CaCl_2 solution; and (d) 29.8 percent CaCl_2 solution (scattered AE activity can be seen for the 29.8 percent concentration)

Acoustic emission (AE) was used by Farnam et al. (2015a) to listen for crack development in samples saturated with 0, 5, 15, and 29.8 percent CaCl_2 solutions (Figure 2-7). For the lower concentrations, a small amount of cracking was noticed as the temperature decreased from room temperature. These cracks are due to the difference in the coefficient of thermal expansion between the aggregate and the matrix. When the freezing begins to occur (-5°C for 0 percent CaCl_2 , -8°C for 5 percent CaCl_2 , and -12°C for 15 percent CaCl_2), however, the acoustic activity increases dramatically, indicating that cracking is taking place because of the expansion caused by the ice formation inside specimen pores (Figure 2-7c). Cracking, however, begins at higher temperatures for samples with a higher concentration upon contact with solution for specimens saturated by 20, 25, and 29.8 percent CaCl_2 (shown in Figure 2-7d). It should be noted that the samples in Figure 2-7 were stored at 23°C (which is consistent with calcium oxychloride; see Figure 2-5), because the formation of calcium oxychloride can cause cracking due to volume expansion.

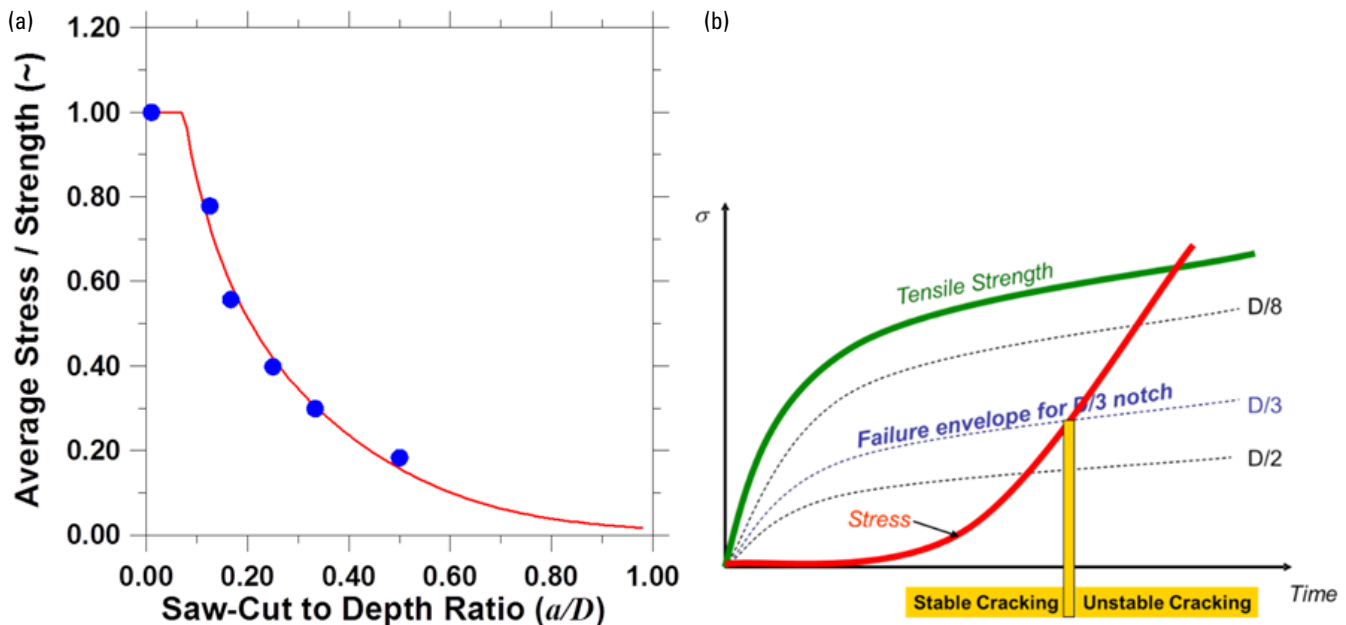
Figure 2-8. (a) Strength and stress development for concrete pavements as a function of saw-cut depth, and (b) the saw cut stress-to-strength ratio

when sawing machines are used with worn bearings or an inappropriate blade or when cutting on a curve. Thier (2005) conducted studies of joint construction, and Raoufi et al. (2008) simulated stress development at the saw-cut joints. It was reported that saw cutting needs to be performed before the stress reaches the tensile strength of the pavement to reduce the potential for random cracking (Raoufi et al. 2007), and this stress reduction factor is related to the depth of the saw cut being used. Figure 2-8 shows that deeper saw cuts require a greater reduction in the stress-to-strength ratio used for saw cutting. It was also observed that micro-cracking can occur at the base of the saw cut when the stress in the pavement is high (Castro et al. 2011), increasing the rate of saturation and freeze-thaw damage (Yang et al. 2004; Weiss 2016).

as shown in Figure 2-8 in the previous chapter. Taylor and Wang (2015) discuss a device (P-wave propagation) that can predict the sawing window for early-entry and conventional saws.

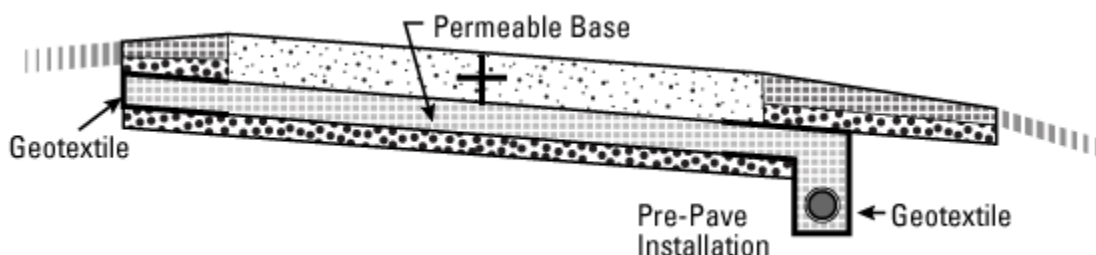
Figure 3-1. Typical cross section of subsurface drainage system

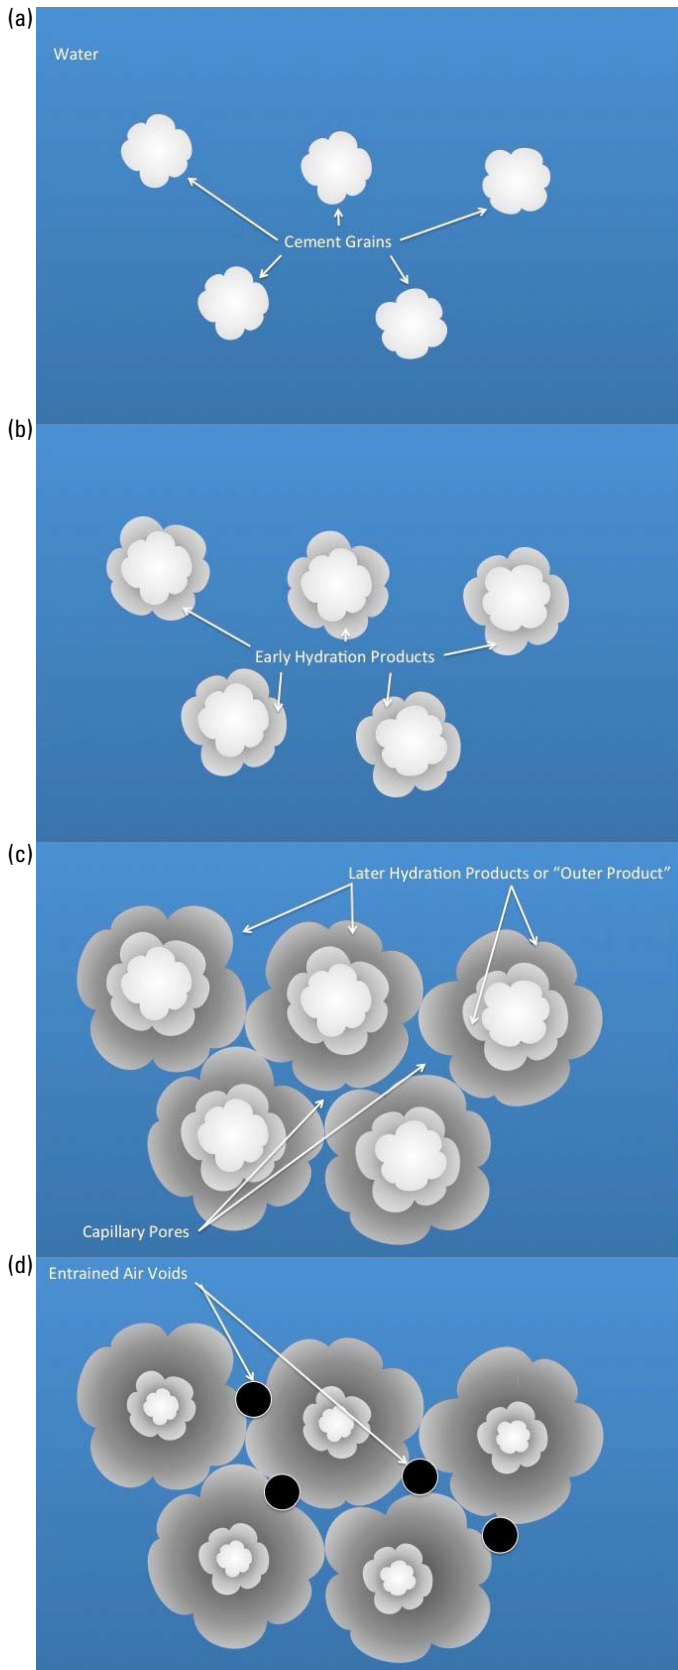
Figure 3-2. Cement grain dispersion and development of hydration products and capillary pores

The hydration of cement essentially produces two principal phases, CSH and CH. The C-S-H phase is considered to be the "cementing" phase whereas the CH phase is present but has little cementing value. The CH forms in platelike crystals that easily fracture. More important, CH is soluble in water. Further, the solubility of CH increases as the temperature decreases. This means when concrete is exposed to water at a temperature near the freezing point, the CH will dissolve more readily. Some of the dissolved CH may re-precipitate within the concrete, but some will exude or otherwise be lost. This process creates an increased permeability and more water ingress, and the process accelerates. As described in chapter 1, the CH is a reactant in the calcium oxychloride

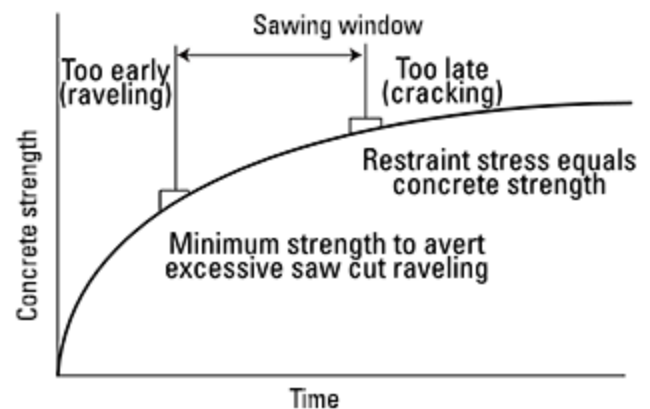
Figure 3-3. Sawing window

Most important, select the correct sawing window. There is no one correct answer for when to saw. The window is determined by the mixture and conditions of placement. In general, the sawing window begins when concrete strength is sufficient for sawing without excessive raveling along the cut; see Figure 3-3. Taylor et al. (2006) propose that the sawing window ends when random cracking starts to occur. Raoufi et al. (2007) have suggested that the sawing window ends as cracking transitions from stable to unstable at the saw cut,

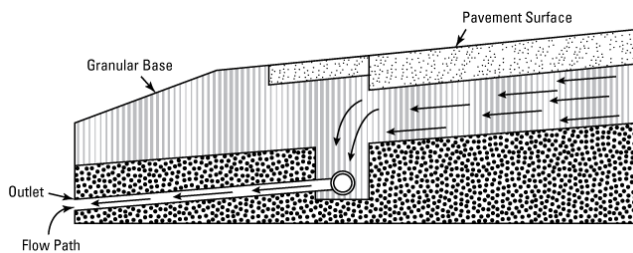
Figure 4-1. Example of shortening drainage path to an outlet

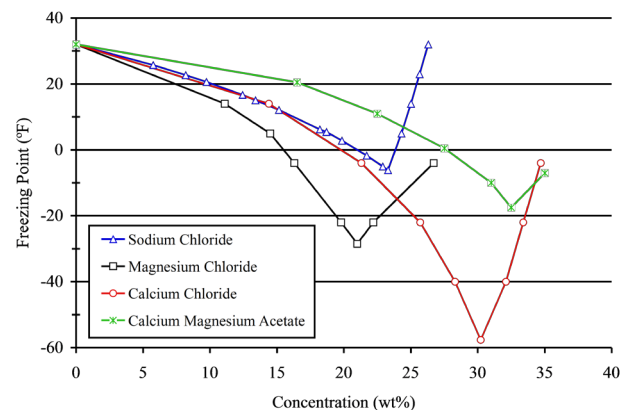
Figure 4-2. Partial phase diagrams for mixtures of water and common deicing/anti-icing salts. The freezing point of the water-salt solution (brine) is plotted as a function of the concentration of salt, in weight percent. Note that for all salts, a minimum freezing point is shown (Sutter 2008)

concentrations or rates will result in less damage to concrete structures. Note in Figure 4-2 that, as the brine solution concentration decreases to a relatively lower value (i.e., less than 5 percent by weight), the freezing points of the solutions become quite similar. This means that, as the brines become more diluted (which occurs as snow and ice melt), the relative difference in effectiveness (i.e., freezing point) diminishes. Therefore, using higher melting point solutions (i.e., brines of $MgCl_2$ and $CaCl_2$) at lower temperatures accomplishes little in terms of maintenance, yet it exposes the concrete to the chemicals most known to cause deterioration.

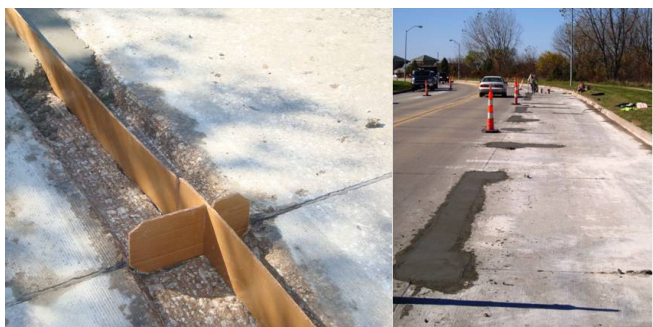
Figure 5-2. Milled joint for removal of spalling (left photo) and finished PDR (right photo, courtesy of City of West Des Moines, Iowa)

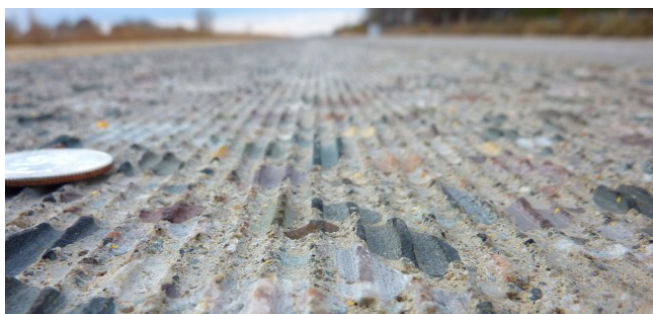
Figure 5-3. Diamond-ground pavement surface (photo courtesy of The Transtec Group)

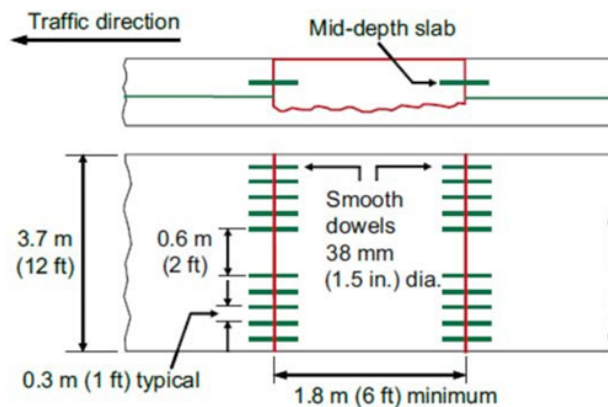
Figure 5-4. Example of FDR (plan view showing dowel bar layout)

Although FDRs can be designed and constructed to provide good long-term performance (see Figure 5-4), the performance of FDRs is very much dependent on their appropriate application and use of effective design and construction practices. Many FDR performance problems can be traced back to inadequate design (particularly poor load transfer design), construction quality, or the placement of FDRs on pavements that are too severely deteriorated.

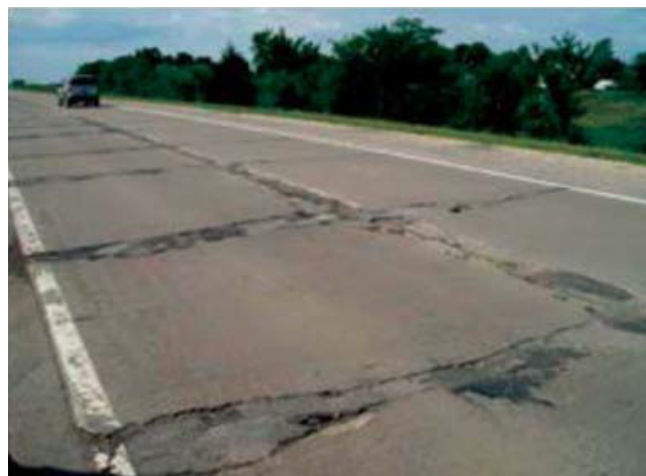
Figure 5-5. Concrete pavement with severe joint spalling (photo courtesy of Todd LaTorella, MO/KS ACPA)

Figure 5-5 shows a concrete pavement in Missouri with severe joint spalling. After careful examination of the pavement, it was decided to construct an unbonded concrete overlay. The

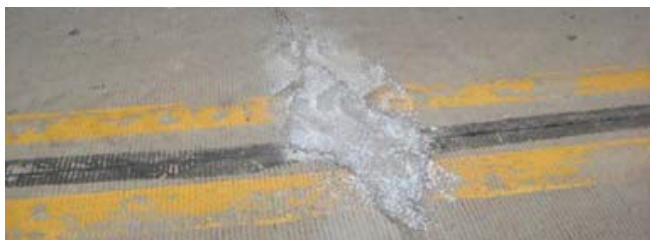
Figure 5-6. Pre-overlay repair of spalled joint (photo courtesy of Todd LaTorella, MO/KS ACPA)

spalled joints were milled and patched with a flowable mortar to fill the void (Figure 5-6). Bonding agents were not used for the patch, and the joints were not re-established.

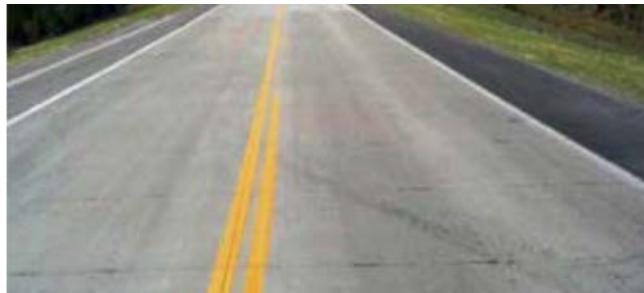
Figure 5-7. Completed unbonded concrete overlay (photo courtesy of Todd LaTorella, MO/KS ACPA)

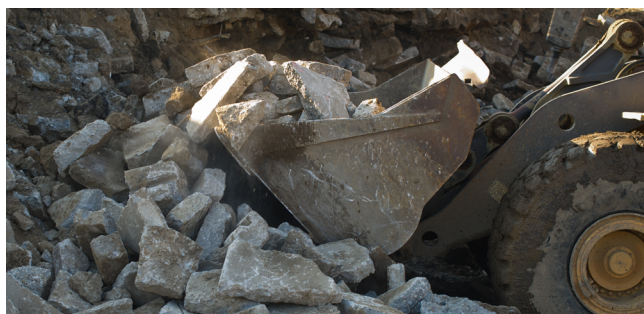
Figure 5-8. Concrete pavement for recycling (photo courtesy of Michigan State University)

In some instances in which pavement deterioration is beyond the state of feasible repair with PDR, FDR, or unbonded concrete overlay, appropriate option is reconstruction in place. Recycling concrete pavements into a base for the new pavement has proven to be a successful option. Recycled concrete aggregate (RCA), as a rule, is a high-quality material for unbound or stabilized applications such as bases compared to conventional new aggregate. An RCA has a rougher surface texture, higher shear strength, higher rutting resistance, and higher resilient modules (Van Dam et al. 2012) (see Figure 5-8).

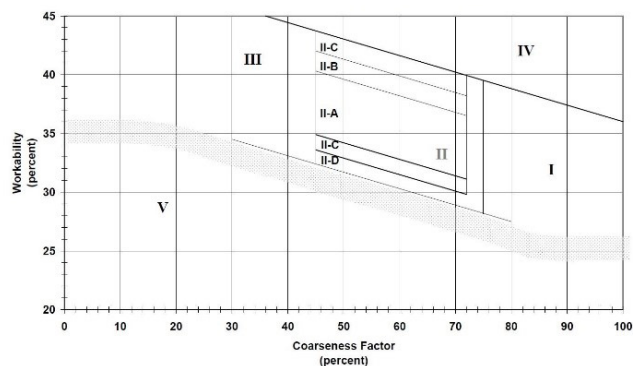
Figure 6-1. Workability factor vs. coarseness factor for combined aggregate

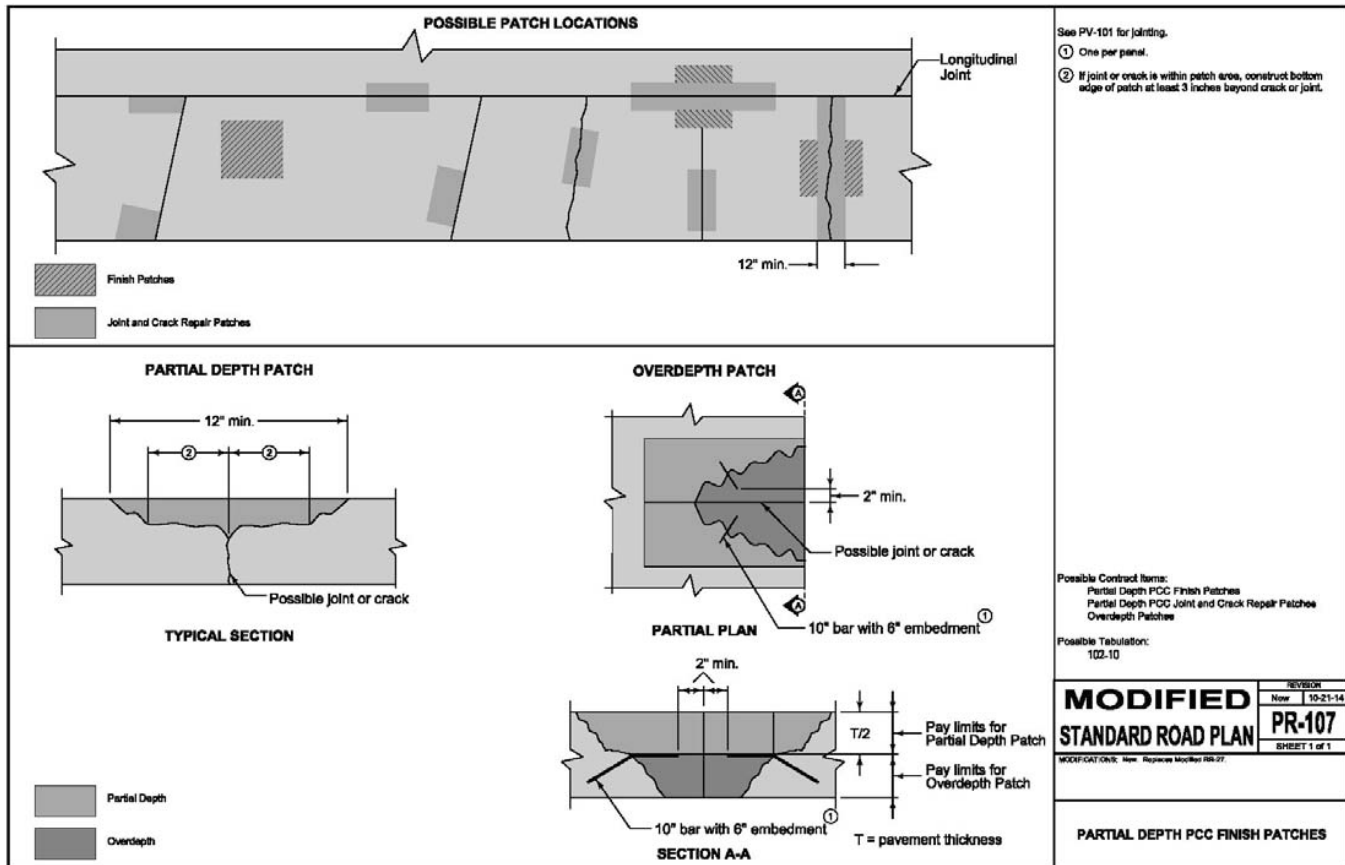
Figure 6-2. Modified Standard Road Plan PR-107

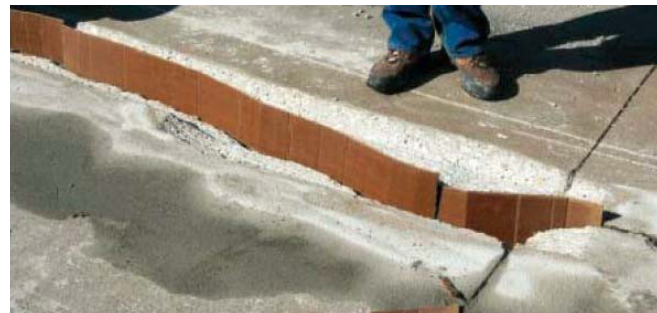
Figure 6-3. Joint board

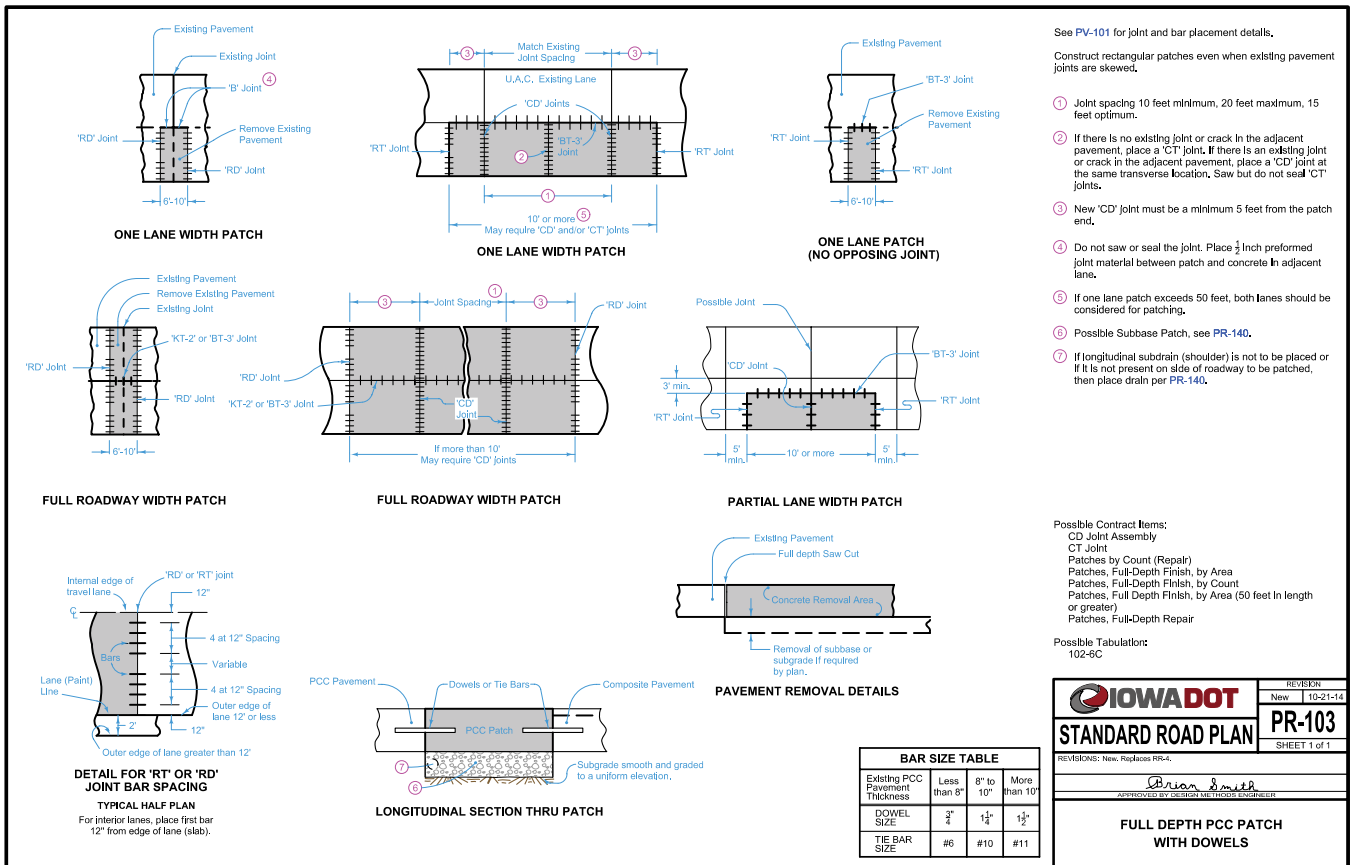
Figure 6-4. Standard Road Plan PR-103 for full-depth patches

Figure 6-4 is the [Standard Road Plan PR-103](#) for full-depth finish patches with dowels. The Iowa DOT includes [Standard Road Plans PR-101 through PR-105](#) for related technical details. Iowa DOT Specification [Section 2529](#) covers Full Depth PCC Finish Patches for several applications including those listed here.
